## Marine Survey Report

**Report Number :** 2010P/1844  
**Date of Inspection :** November 2, 2010  
**Commissioned by :** XXXXXXXXXXXX for pre-purchase purposes  
**Address :** XXXXXXXXXXXX  
XXXXXXXX  
XXXXXX  
**e-mail :** XXXXXXXXXXXXXXXX  
**Phone :** 647-XXX-XXXX

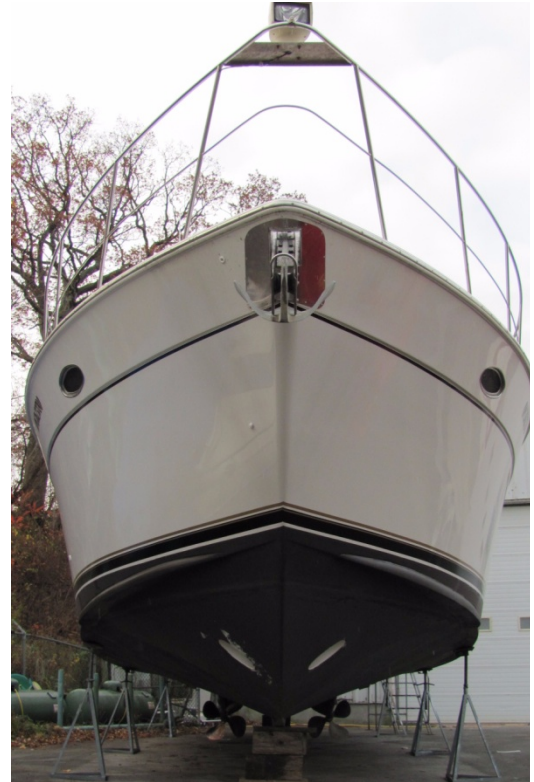
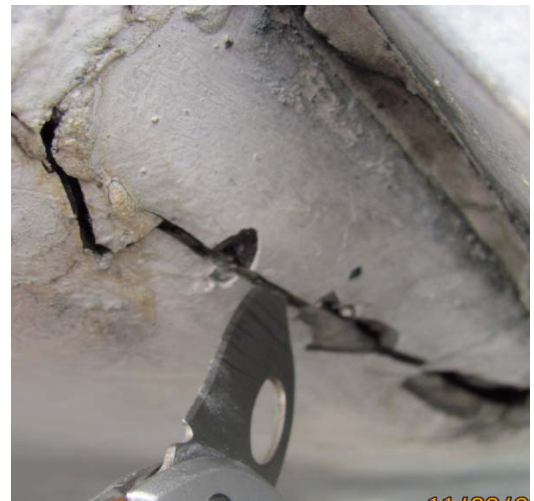
**Transom :** Moisture levels are in the low range. The transom checks sound but for the area around the lower hydraulic arms for the extended platform. These areas are fractured and show evidence of previous repair. [See comment \(1\)](#).

*Fracture under port swim platform hydraulic arm*

1. Excavate previous repair and repair again.
2. Strip bottom, re-inspect and repair as required.
3. Re-bed all stanchions bases and repair gelcoat fractures as required.
4. Significant modifications are required to properly support the swim platform.
6. Pull rudder stocks for inspection and re-pack stuffing boxes as required.
13. Repair radar display as required.
15. Repair Raymarine Raychart 600XX as required.
16. Repair Raytheon NAV 398GPS/Loran as required.
17. Repair AC outlet at the wet bar on the aft deck.
20. Transport Canada TP1332E and ABYC "AC & DC Electrical Systems" require that a vapour proof battery disconnect switch be readily accessible. TP1332E defines readily accessible as "means capable of being reached for inspection, maintenance or usage under emergency conditions". *It is the surveyors' opinion that these switches are not readily accessible.*

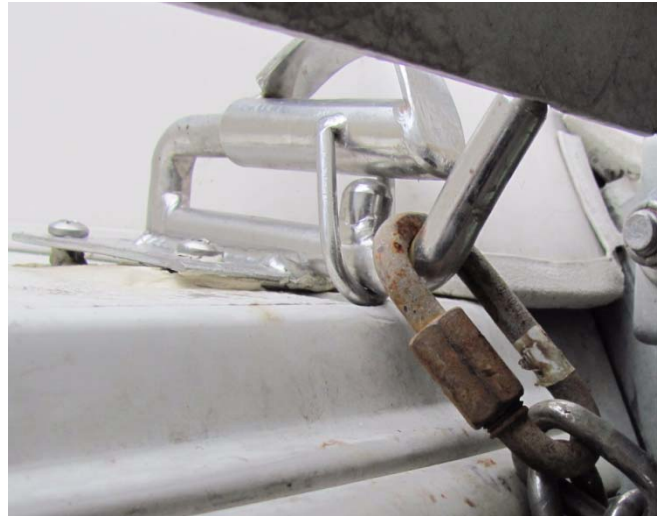
The stern is fitted with a secure transom locker, moulded swim platform and a hydraulically activated dinghy platform. The aluminum dinghy platform arms show significant corrosion with what appears to be jury rigged additional support from chains to Weaver type davit mounts fastened to the swim platform. The port mount is pulling free from the platform. See comment (4).

*Weaver davit being used as a chain mount to support the dinghy platform and pulling free of deck.*

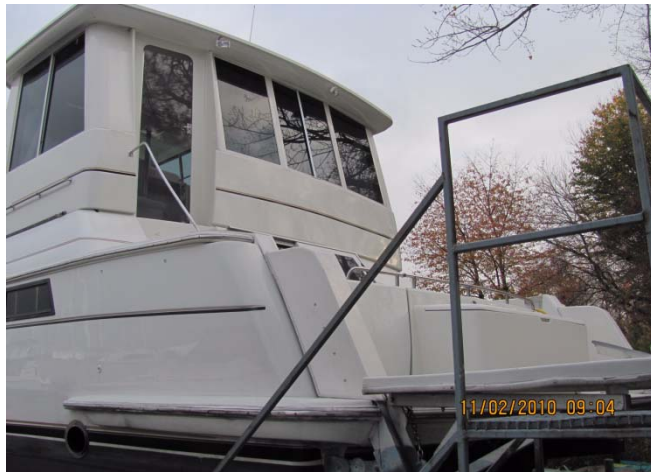
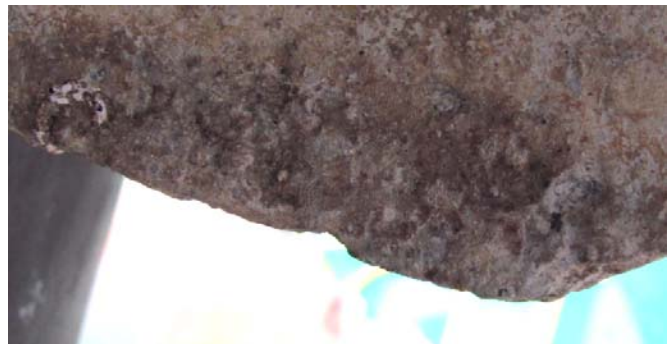
*Corroded dinghy platform lifting arm.*

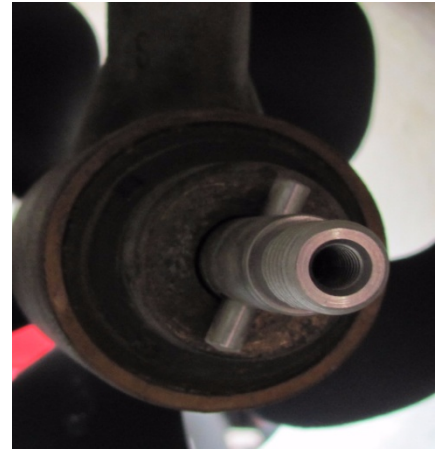
**Thrusters :** One 12VDC bow thruster with missing hub cover.  
See comment (7).

*Missing thruster hub cover*

5. Touch up paint blisters on aluminum framework.
7. Replace missing hub cover on bow thruster.
8. The Canada Shipping Act prohibits the discharge of petroleum products. The addition of drip pans under the engines will help prevent such discharges through the bilge pumps.

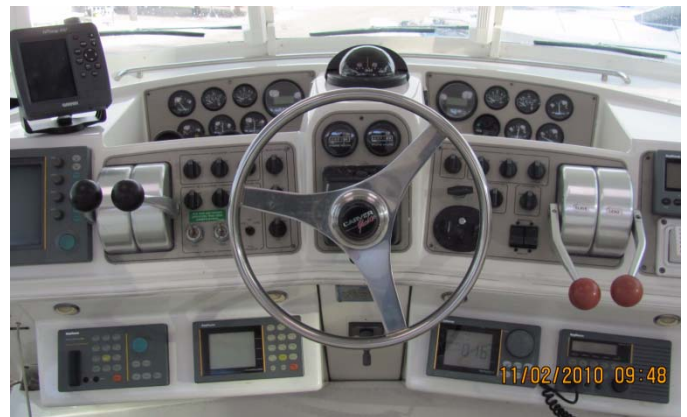
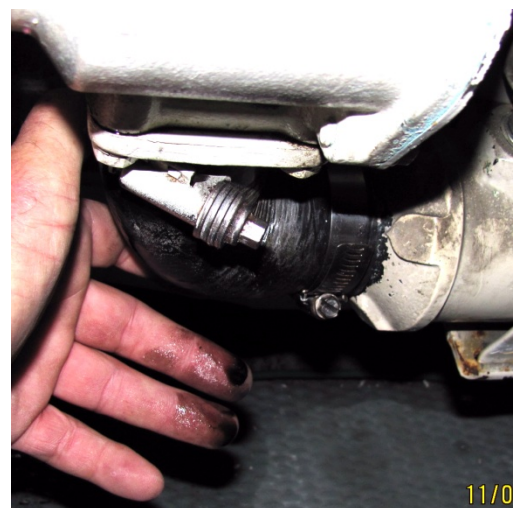
**Cooling system:** Heat exchangers with raw water exhaust cooling. There is a significant oil leak at the forward end of the port engine oil cooler at the hose leading to the raw water pump. See comment (9).

*Oil leak at oil cooler close to raw water pump on port engine.*

9. Repair oil leak on port engine at heat exchanger.
19. Repair cut wires and bare twisted wire connection under non-functional navigation equipment at helm.

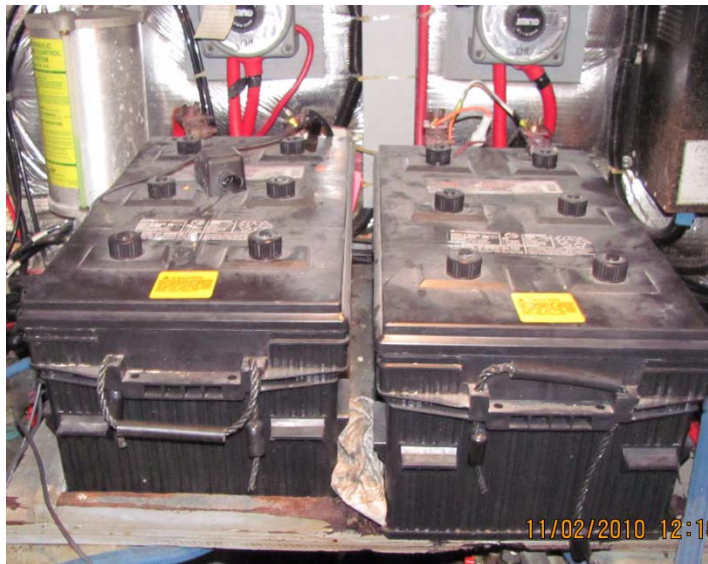
**Batteries :** One sealed group 27wet cell at the bow thruster in an adequately secured plastic box but without positive terminal protection and wing nuts securing conductors. One group 24 12VDC sealed wet cell at the generator in an adequately secured plastic box but without positive terminal protection and wing nuts securing conductors. Two 8D wet cells with low electrolyte aft of the engines are gassing excessively, are not secured, not in boxes to capture spilled electrolyte, conductors are secured with wing nuts and an alligator clip (from a light) is corroded to a terminal. See comment (21).

*8D's aft of engines*

21. Replace both 8D batteries. ABYC "Storage Batteries" Standard E-10 and TP1332E require in part that batteries be vented outside of accommodation spaces and that batteries be secured so as not to move more than one inch in any direction, be contained in boxes or trays resistant to electrolyte, that positive terminals be protected by dielectric material and prohibits wing nuts and alligator clips as a means of securing these conductors.

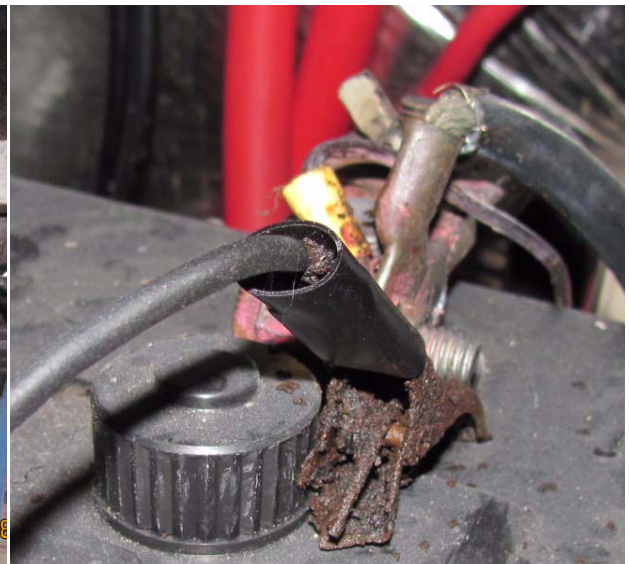
*Corroded alligator clip*

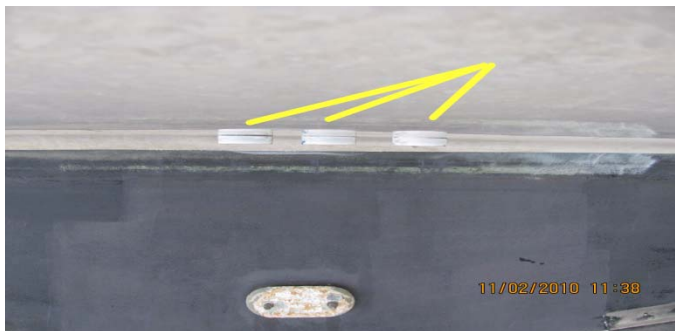
Photo below - The three throughhulls on the underside of the swim platform are within an inch or two of the water line and are not fitted with seacocks. See comment (24).

23. Replace both a/c intake hoses.
24. Install seacocks on un three throughhulls on underside of swim platform. TP1332E requires that "Means shall be provided for positively shutting off underwater penetrations (except for wet exhaust systems) ". ABYC "Seacocks, Thru-hull Connections and Drain Plugs" Standard H-27 requires in part that a seacock be of the lever activated type, be readily accessible and withstand a static force of 500lbs. applied to the inboard end.
