MARINE SURVEY REPORT

Report Number : 2006P/1004
Date of Inspection : August 18, 2006
Commissioned by: [REDACTED] for condition and evaluation purposes
Address : [REDACTED] East
Stoney Creek, Ontario
L8E [REDACTED]
Phone : 905-[REDACTED]-[REDACTED]
e-mail: [REDACTED]

Make of Vessel -- Marine Trader built by Chien Wha Yard, Taiwan.
Name of Vessel -- [REDACTED]
Model year -- 1985
Date of mfg. -- February 1985
License Number -- 25E [REDACTED]
HIN/MIC -- ETY [REDACTED] B585

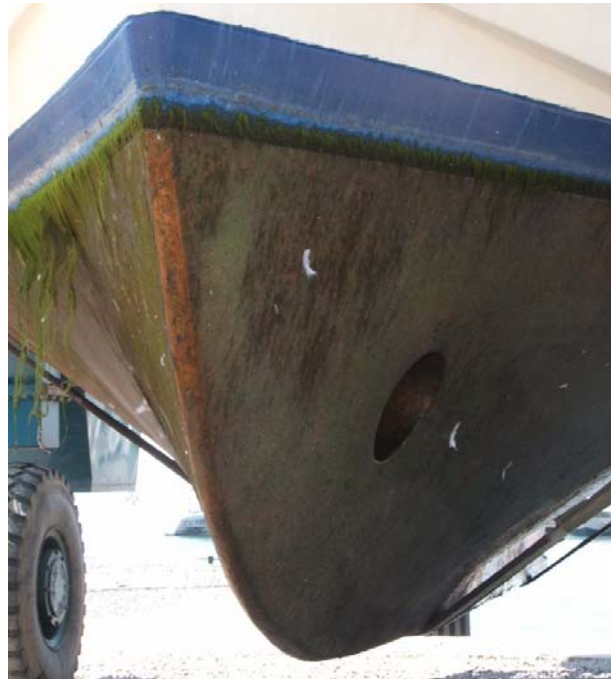
Bottom : The bottom painted with an ablative type anti-fouling paint in good condition. Moisture levels were not measured as the vessel had just been lifted from the water. All surfaces are free of blisters and check sound with the exception of two repairs on the starboard midship chine. The forward repair appears secure however, the aft most repair appears to be a piece of laminate "stuck" back on with a caulking material and squirts water when pressed upon. The keel bottom shows evidence of multiple repairs which while crudely done appear sound. [See comment \(2\)](#).

2. This "loose" repair on the starboard chine should be excavated and repaired as required.
3. Various high moisture and fractured areas pose no threat to the vessel but do have a negative effect on value.
4. Re-bedding all deadlights, ports and windows may help reduce leakage and further water staining.
7. Canada Shipping Act – TP1332E 7.7.1 requires every fuel filter or strainer shall meet the fire resistance requirements for fuel systems set forth in ABYC Standards for Small Craft H-24.5.7 unless the filter or strainer is inside the fuel tank. No plastic bowl filters without heat shields meet this standard.

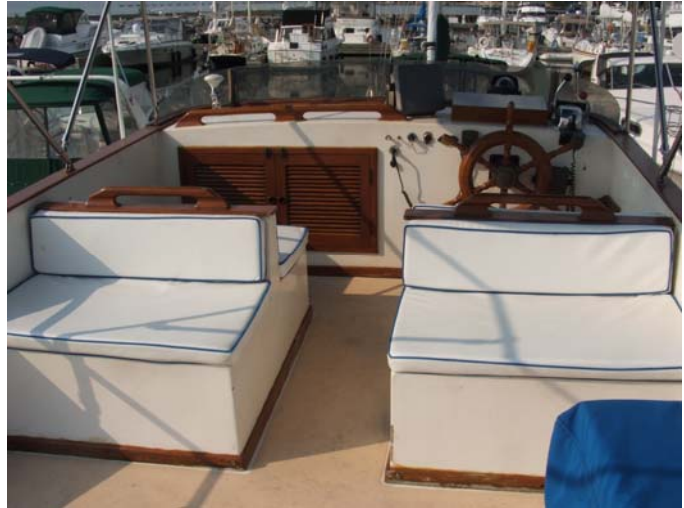
The flying bridge deck checks largely sound with moisture levels in the low to slightly elevated range with the exception of the starboard aft corner which shows fractures through the laminate and very high moisture levels. [See comment \(3\)](#).

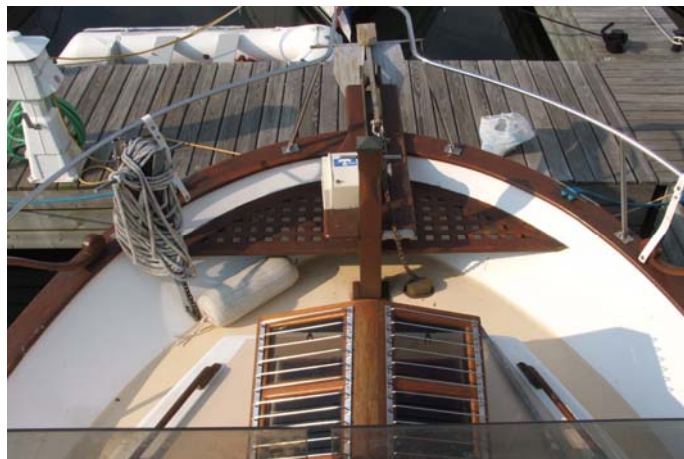
Stainless steel bow and side rails with teak caps are secure as are bow, midship and stern mooring cleats. A teak bow platform is fitted with a single anchor roller and is followed by a windlass and rode pipe. On the fore trunk a wooden hatch, two bronze ports and teak grab rails are secure and in good condition. The deck house checks sound with moisture levels in the low range. Two deadlights and an opening windshield forward are secure, on the house sides are a sliding companionway door, sliding windows and deadlights all of which are secure. On the trunk are two sliding windows and one deadlight all of which are secure. All sliding windows and deadlights have been sealed with a silicone type caulking material and leakage is suspected. All ports and windows are secure but most show signs of leaking. [See comment \(4\)](#).

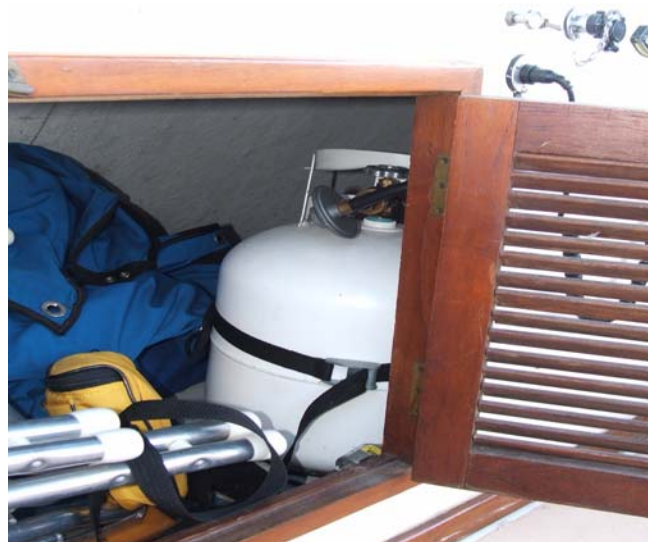
A galley stove is propane fueled and supplied from a 20lb. bottle inadequately secured by a nylon strap (see photo at right) under the flying bridge coaming.

The bottle is not stored in a "dedicated locker" and is exposed to the under dash DC electrical system. No dedicated or direct overboard drainage or pressure gauge is provided. [See comment \(10\).](#)

6. Transport Canada TP1332E and ABYC "Exhaust Systems" Standard P-1 require in part that all exhaust hose connections be double clamped.
10. NFPA-302 and ABYC "Marine Liquefied Petroleum Gas (LPG) Systems" Standard A-1 require that propane fuel bottles be stored securely in a dedicated, top loading locker with gasketed lid and direct overboard drainage from the bottom of that locker and that the system be fitted with a pressure gauge and a remotely controlled shut-off switch located at the appliance that may be reached without reaching over the appliance.

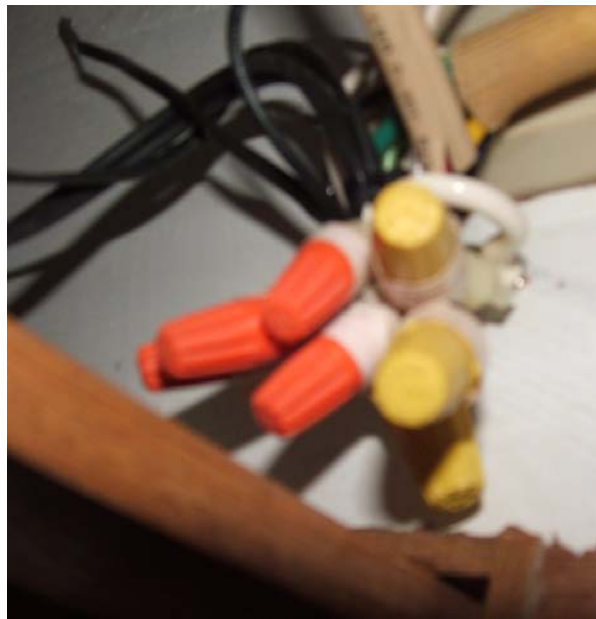
Conductors : A mix of stranded and solid core copper conductors. The V-berth outlet (see photo at right) has seventeen conductors connected with seven wire twist connectors.
[See comment \(13\)](#).

G.F.C.I. outlets : One G.F.C.I. is fitted in the V-berth and the test button functions but there is no power from the outlet.
[See comment \(14\)](#).

13. Transport Canada "Constructions Standards For Small Vessels", TP1332E requires conformance with ABYC "AC and DC Electrical Systems On Boats" Standard E-11 which in part requires that conductors be of stranded copper and be identified as having a minimum voltage rating of 600volts. That wire twist connectors are prohibited. *Seventeen conductors in seven wire twist connections is dangerous !*

14. This is the outlet mentioned in item **13**. and must be corrected immediately.
15. Transport Canada "Constructions Standards For Small Vessels", TP1332E requires conformance with ABYC "AC and DC Electrical Systems On Boats" Standard E-11 and NFPA 302 which in part require that the first outlet in each circuit and others where splash is likely. i.e. galley, shower, cockpit be protected with a G.F.C.I. and require that all AC outlets be contained in a box that meets UL514A or 514C.
