MARINE SURVEY REPORT

Report Number : 2009S/1582
Date of Inspection : October 30, 2009
Commissioned by : [REDACTED] for pre-purchase purposes
Address : [REDACTED]
Laval Québec
H7C XXX
e-mail : [REDACTED]@ [REDACTED].com
Phone : 514-771- [REDACTED]

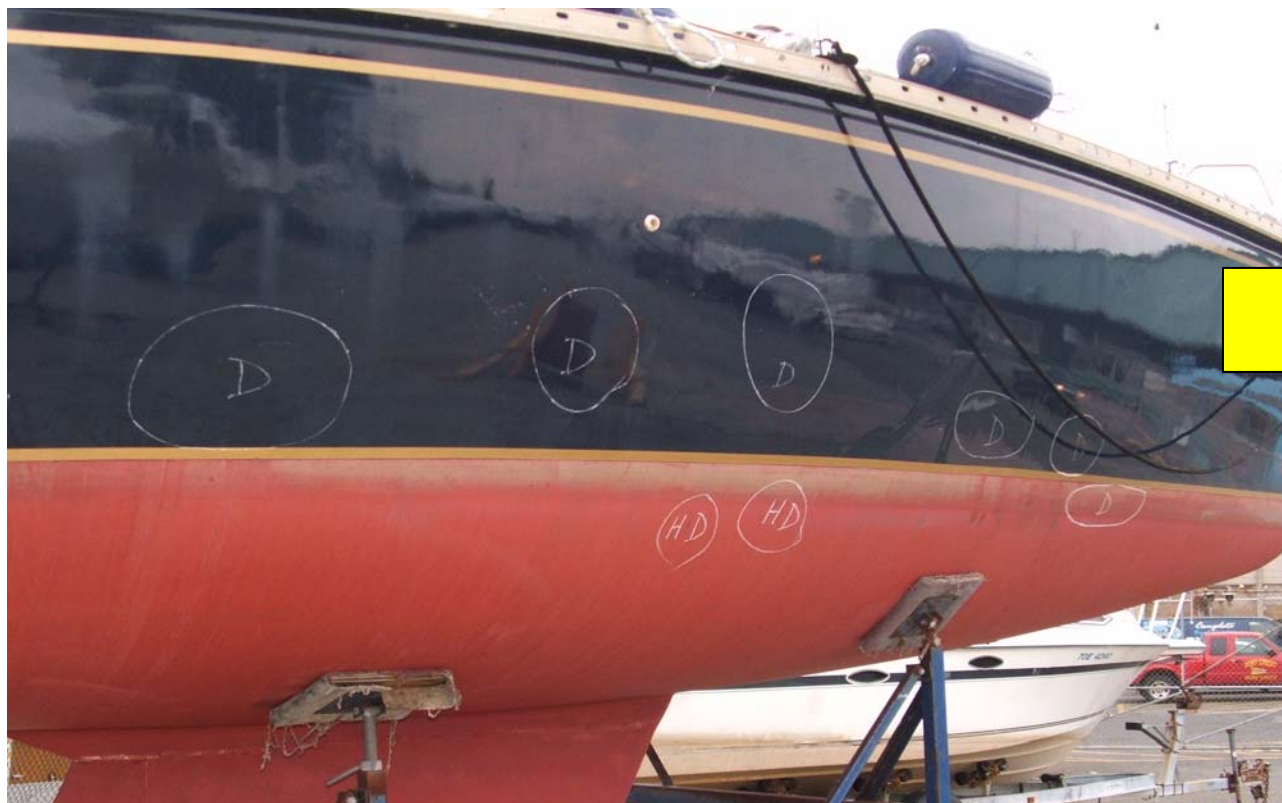
Bottom : The bottom is fair and checks sound but for noted exceptions with moisture levels highly variable from low to high. Anti-fouling paint is in good condition. As shown in the photo below there are two areas of dull checking with high moisture levels and one area of dull checking. [See comment \(3\)](#).

Topsides : The topsides have been painted. In the photo below dull checking in the five unfair areas circled indicates delamination and or core separation. [See comment \(3\)](#).

*Chalk circles show areas of concern on the starboard side.
“D” = dull checking. “H” = extremely high moisture levels.*

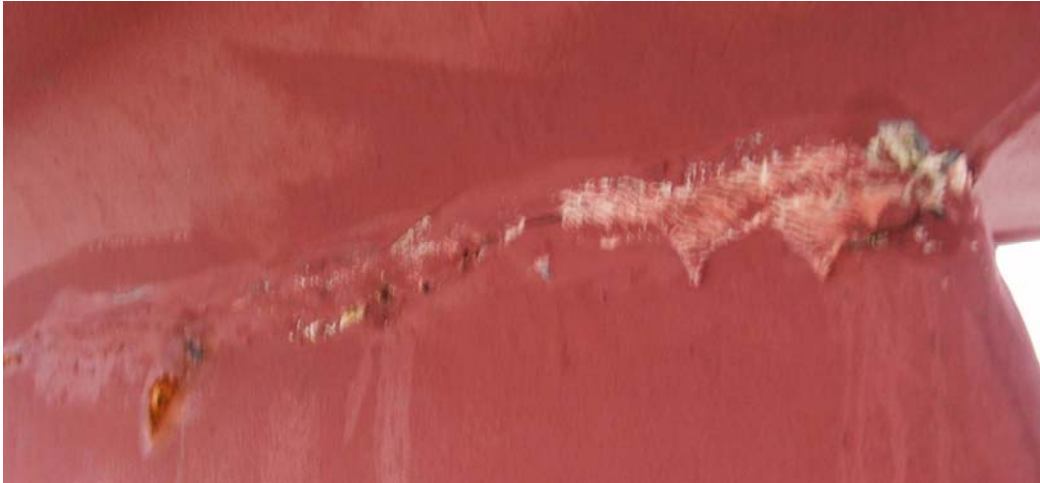
Keel / hull joint : The joint is crudely caulked and shows weeping stains. [See comment \(5\)](#).

Crudely caulked and weeping keel / hull joint.

5. Keel hull joint to be checked for leakage when vessel is launched.
10. It is the opinion of the surveyor that these anchors are too small for this vessel.

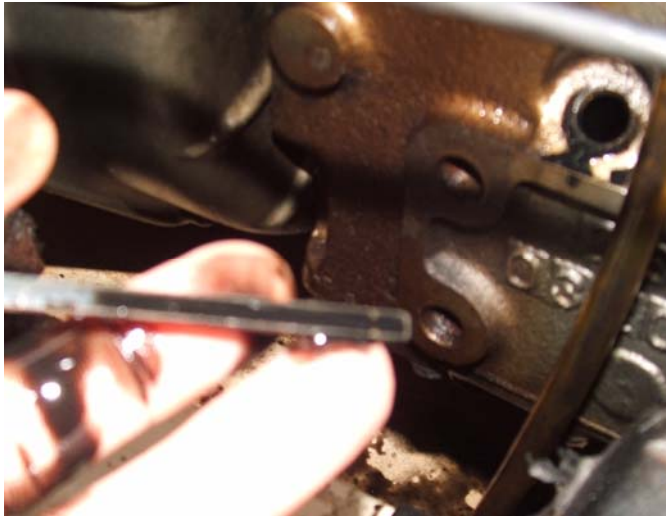
The engine and compartment are in generally clean and orderly condition. A can of "QUICK START" was found on board. Engine oil is dirty. See comment (2).

Dirty engine oil.

2. The dirty engine oil, lack of coolant, sludge in the heat exchanger and sludge leaking around the exhaust mixing elbow suggest there may be problems with this engine. The can of "Quick Start" found on board suggests starting problems with the engine. Use of "Quick Start" in a diesel engine is extremely dangerous. The engine should be examined by a qualified diesel mechanic and the inspection should include a compression test.
3. These areas of delamination / core separation and high moisture require invasive testing to determine the extent of the damage.
17. TP1332E requires that " Means shall be provided for positively shutting off all underwater penetrations (except for wet exhaust systems) ". *A seacock must be added to vanity sink drain throughhull.*

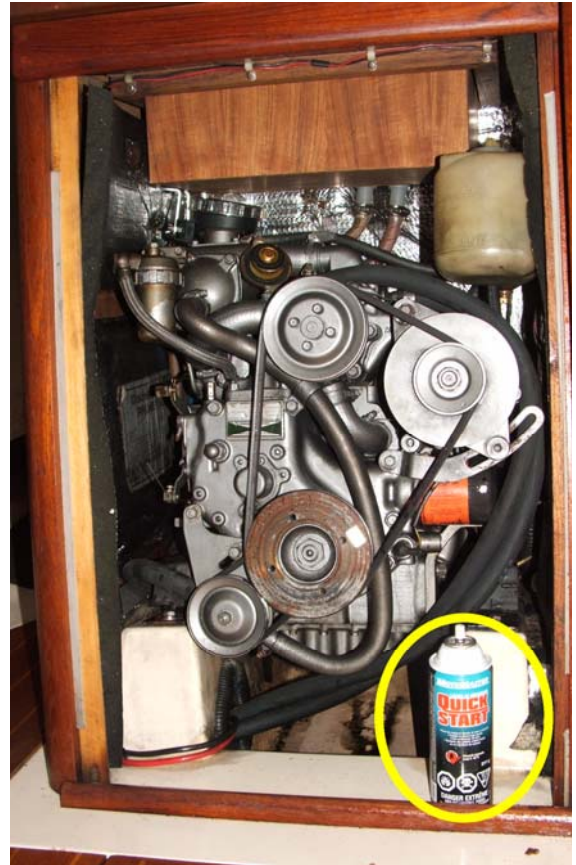
Can of "QUICK START" in yellow circle

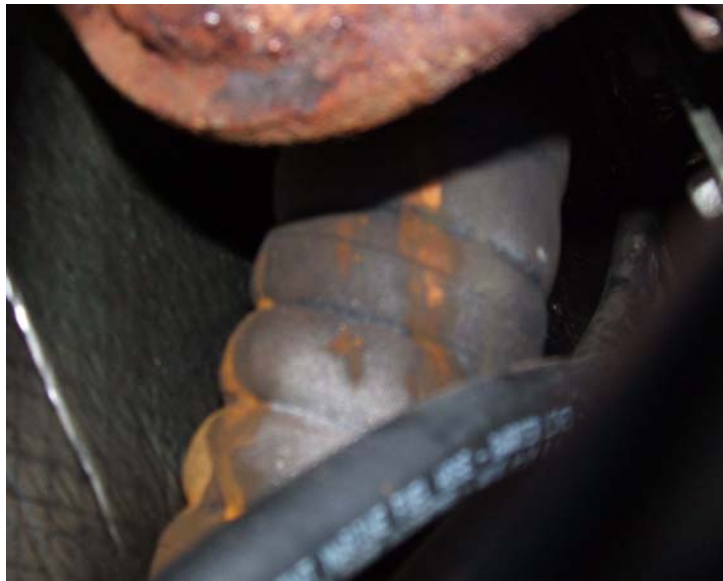
- Ventilation :** Satisfactory.
- Drip pans :** Integral to FRP liner.
- Cooling system:** Heat exchanger with raw water exhaust cooling. The coolant reservoir is empty and inserting a finger in the heat exchanger produced only a brown sludge wiped from the exchanger walls but no coolant. A similar sludge is on the exhaust hose just below the mixing elbow and this suggests a leak from the elbow. See photos next page. See comment (2).

Brown sludge stains on exhaust hose below mixing elbow

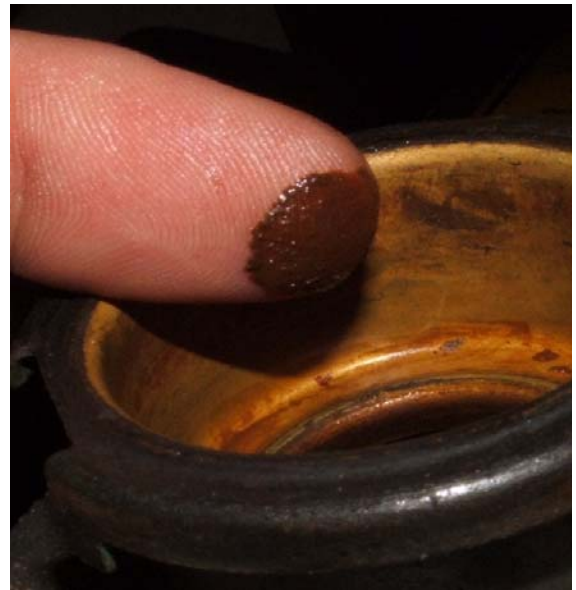
Brown sludge but no coolant in heat exchanger

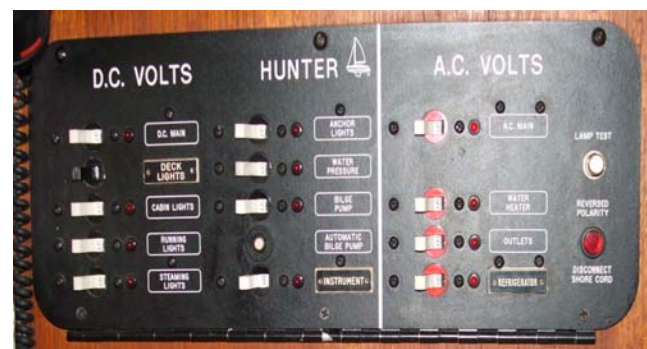
AC panel : Original equipment type panel with single pole main breaker, polarity indicator and accessory breakers in good visual order but without a volt meter and sharing a panel with the DC system.
See comment (13).

Shared DC & AC panel

11. Port running light conductor is corroded and not reliable.
13. Transport Canada "Constructions Standards For Small Vessels", TP1332E requires AC and DC distribution systems not share the same panel board and if both systems share a common enclosure must have a means of clearly separating the two systems with a dielectric barrier. ABYC "AC and DC Electrical Systems on Boats", Standard E-11 permits AC and DC to share the same panel but requires that access to energized parts of the AC side need further use of tools. A volt meter is required if a battery charger is connected.
