Marine Survey Report

Report Number : 2010S/1882
 Date of Inspection : January 01, 2011
 Commissioned by : XXXXXX XXXXXX
 Address : XXXXXXXXXXXXX
 XXXXXXXXXXXXX
 XXX XXX
 e-mail : XXXXXXXXXXXXX
 Phone : 416-XXX-XXXX

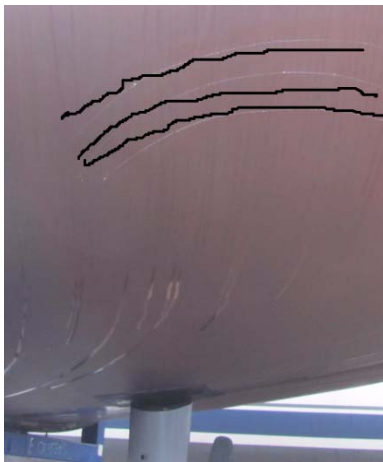
Bottom : The bottom is fair and checks sound. Moisture levels were not measured due to ongoing rainfall. VC17 anti-fouling paint is in good condition. There are multiple elliptical fractures on either side of the sail drive. [See comment \(1\)](#).

Port side fractures 3' outboard of saildrive

1. These bottom fractures are directly under frame members integral to the liner and appear to be superficial in nature. There is no corresponding damage to the frames as viewed from inside the vessel.

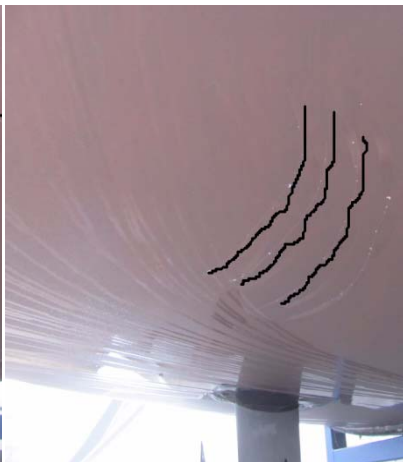
Stb. side fractures 2' outboard of saildrive

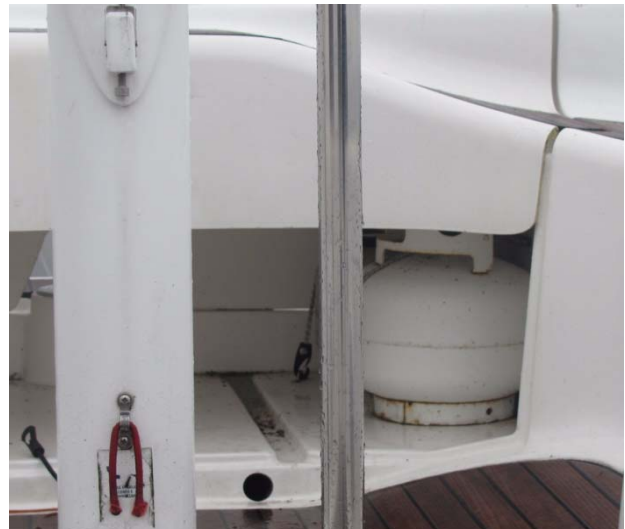
A galley stove is propane fueled and supplied from two approved type bottles stored under the pilot seat and open to the cockpit.
See comment (5).

Propane bottle storage open to cockpit.

5. NFPA-302 and ABYC "Marine Liquefied Petroleum Gas (LPG) Systems" Standard A-1 require that propane fuel bottles be stored securely in a dedicated, top loading locker with gasketed lid and direct overboard drainage with a minimum ½" inside diameter from the bottom of that locker.
11. Transport Canada TP1332E requires that all appliances be installed in accordance with manufacturer's instructions. The battery charger manufacturer requires that this chassis be grounded.
12. The positive conductor from the battery to the charger should be red and requires replacement as it is burnt.

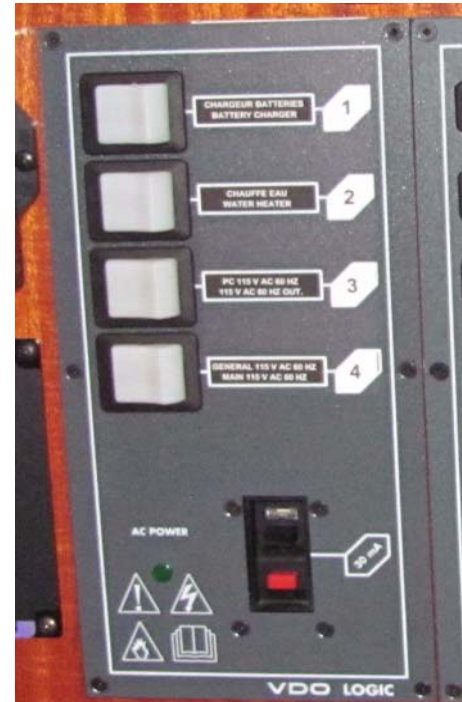
AC panel : Original equipment type panel with single pole main breaker and accessory breakers in good visual order but without a polarity indicator or volt meter. There is approximately 20' of cable between the shore inlet and the panel. See comment (8)

4. Coolant to be topped up when engine is started and monitored. The addition of an expansion overflow reservoir is advised.
8. Transport Canada "Constructions Standards For Small Vessels", TP1332E requires conformance with ABYC "AC and DC Electrical Systems On Boats" Standard E-11 which in part requires that AC panels be fitted with a double pole main circuit breaker or a single pole breaker and polarity indicator and that circuit protection be fitted at no more than 10' of conductor length from the shore power inlet.

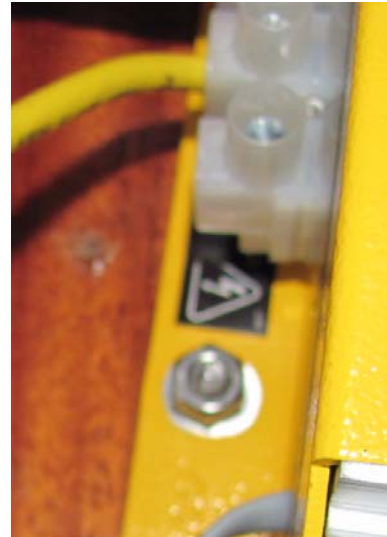
- Inverter :** None sighted.
- Battery charger :** Truecharge 40amp unit is set for “gel” type batteries and the chassis ground is not connected. See comment (11).
- Isolator :** No galvanic isolator sighted.
- Transformer :** No isolation transformer sighted.

Unconnected chassis ground

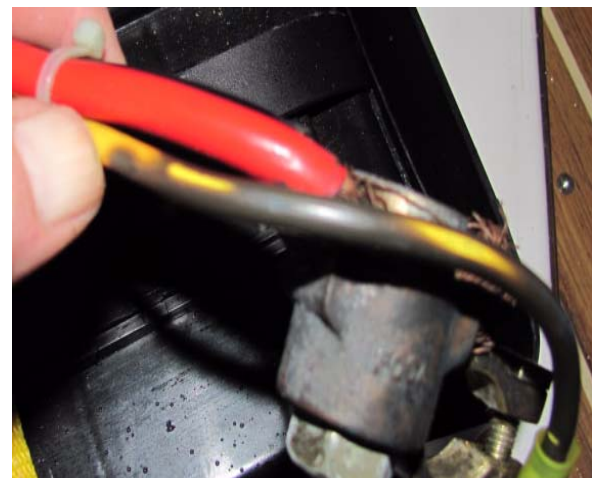
Conductors : Stranded copper where accessible. The battery charger conductor at the battery is burnt and yellow. See comment (12).

Burnt charger conductor at starting battery
