Marine Survey Report

Report Number : 2014S/2971 Date of Inspection : January 12, 2014

Make of Vessel : Catalina 42
Name of Vessel : [REDACTED]
Model year : 2005
Date of mfg. : January 2005
License Number : [REDACTED]
HIN/MIC : [REDACTED]

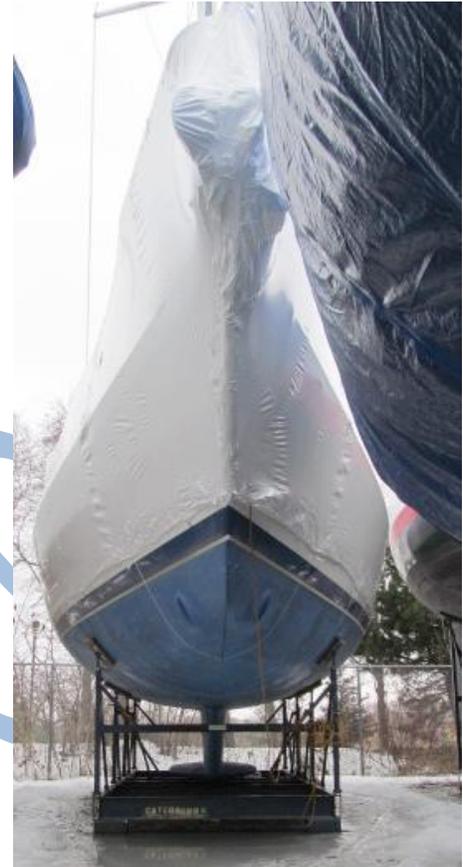
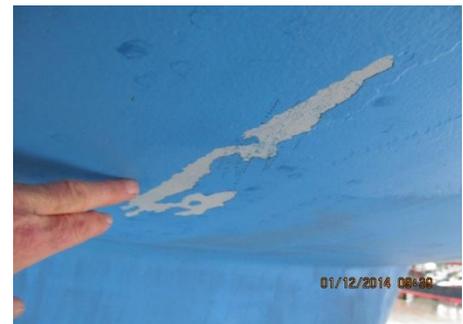
Bottom : The bottom checks sound and appears fair with moisture levels in the low range. Anti-fouling paint over an epoxy barrier coating is flaking but in serviceable condition. **See comment (1).**

Flaking bottom paint

1. Prepare and re-coat anti-fouling.
2. Clean corrosion from vang lower mount rivets and monitor.
3. Clean corrosion from lower port terminals and monitor.
11. Ensure continuity of less than one ohm between any anode and the metal to which it is secured. Almost all boats come from the factory with zinc anodes which are not suitable for fresh water. Magnesium is the anode material recommended for fresh water.
12. Be aware that only the aft shore power line is protected by the galvanic isolator.
13. Installation of a bilge high water alarm is advised.
14. Cabin doors may fit properly when boat is in water.
15. Water heaters can be expected to have a significantly shortened life due to corrosion if no air space is provided underneath such as this installation.

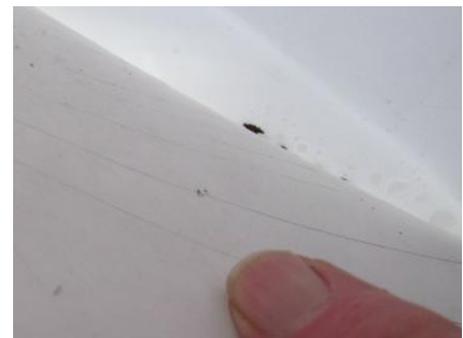
Transom : The transom checks sound with moisture levels in the low range. There are very fine hairline fractures to starboard of the re-boarding ladder mount. Wet locker hatches are sound and secure.

Transom hairline fractures

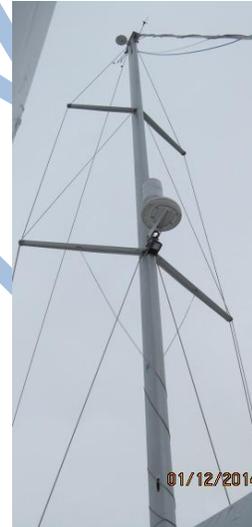
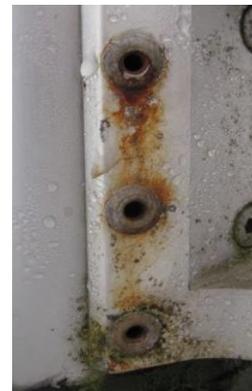
Boom(s) : The aluminum extruded boom with internal track appears fair and sound with gooseneck, stainless steel rigid vang and all fittings secure. There are corrosion stains running from the rivets at the lower vang mount. **See comment (2).**

Vang rivets corrosion stains

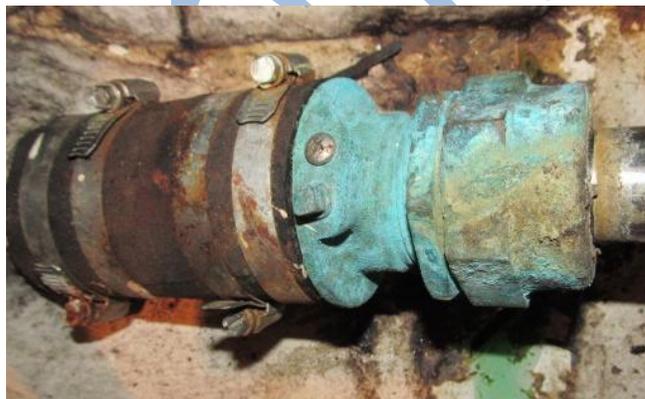
Corroded clamps and stuffing box

- 4a. Replace corroded gear clamps.
7. Remove impeller for inspection prior to starting engine as there is no way of knowing when this cover plate was scorched.

- 4b. Replace cutless bearing. Clean corrosion from stuffing box and re-inspect.
5. Inspect propeller blades when located.
6. Repair tachometer as required.

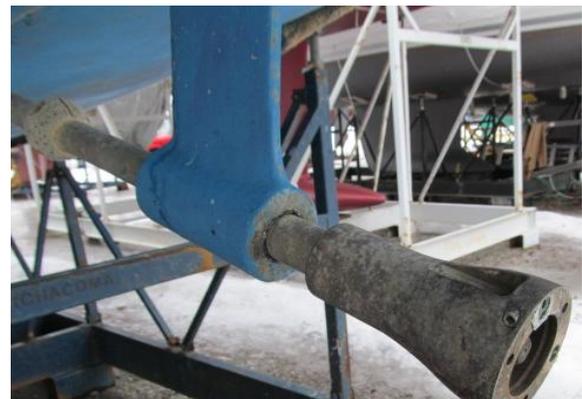
Feathering propeller, missing blades

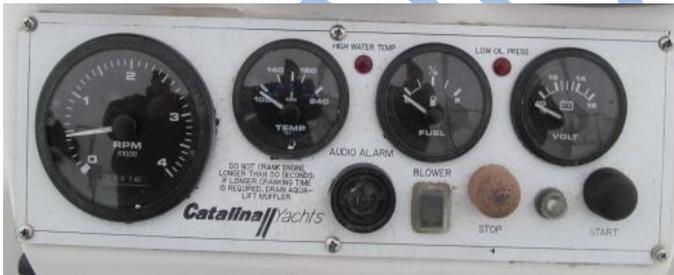
Engine controls : Dual function lever to cables is secure and free moving. Engine ignition panel includes fuel gauge, temperature gauge, volt meter, blower control, overheat alarm, hour meter and tachometer. All are clear and secure but tachometer is stuck at 1000RPM. **See comment (6).**

Tachometer stuck at 1000RPM

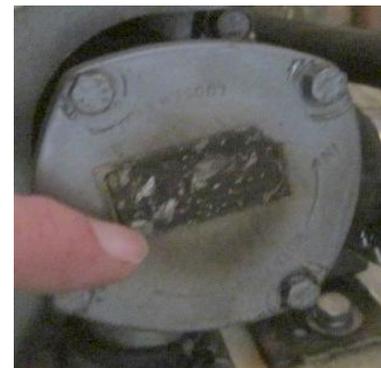
Cooling system : Closed circuit cooling with heat exchanger and raw water exhaust cooling is free of visible leakage. The impeller cover plate is in place and appears to be scorched. **See comment (7).**

Scorched impeller cover plate

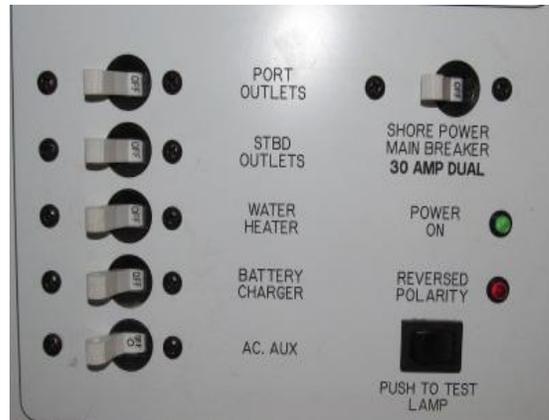
AC panel : Original equipment type panel with single pole main breaker, and polarity indicator at panel, sharing the panel with the DC system but with required dielectric separation. There are two 30amp inlets. One single pole main is in the starboard lazarette locker servicing the transom inlet. No circuit protection could be located between the rode locker inlet and the panel. No method of switching between fore and aft inlets could be located.
See comment (8).

AC panel showing only one main breaker

8. Without AC power it could not be determined if the forward AC inlet is stand-alone or is run to the main panel. If it runs to the main panel, a lock out switch must be fitted that both inlets cannot be energized at the same time; In either case it must have circuit protection within 10' (cable length) of the inlet.

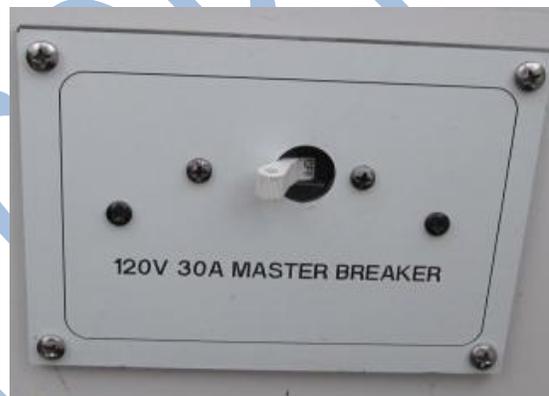
Single pole main in stb. lazarette locker

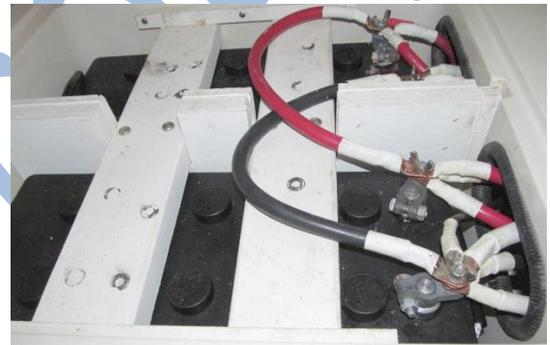
Two 4D batteries under aft berth

10. ABYC "Storage Batteries" Standard E-10 and TP1332E require in part that batteries be vented outside of accommodation spaces, that positive terminals be protected by dielectric material, prohibits wing nuts as a means of securing conductors 6AWG and larger and requires positive conductors be fuse protected within 7" of the battery or 40" if the conductor is fully enclosed with the exception of the conductor running to the engine starter motor.

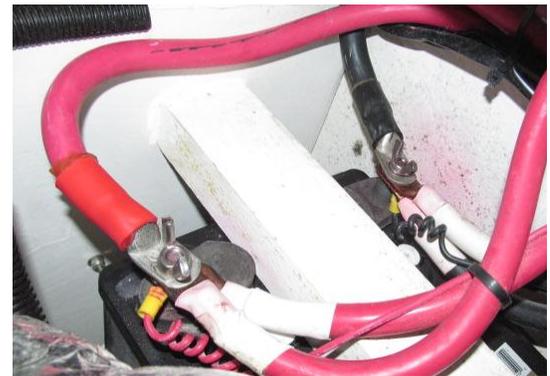
Batteries : Two sealed, 4D, 12vdc wet cells and one 4D 12VDC wet cell. The single battery under the dinette is low on electrolyte. All terminals are secured with wing nuts and three terminals on the two batteries under the aft berth are loose and one terminal has five connections. There is no fuse protection, no positive terminal protection and no ventilation outside of accommodations spaces. **See comment (10).**

One 4D under dinette

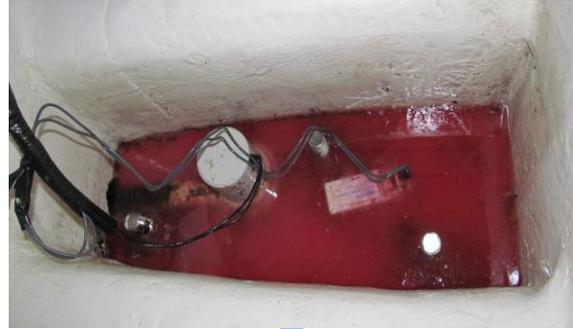
The interior headliners, sole panels, cabinetry and upholstery are in clean, sound and in very good condition. There is some mold in various areas on the inner hull surface. Bilges appear clean with a few inches of anti-freeze. Cabin doors would not close. **See comment (14).**

Saloon bilge
