Marine Survey Report

Report Number : 2013P/2885

Date of Inspection : July 10, 2013

Make of Vessel : Silverton 410 Sportbridge

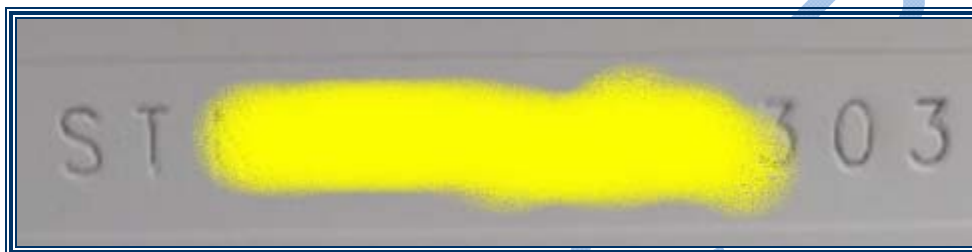
HIN/MIC on upper starboard transom

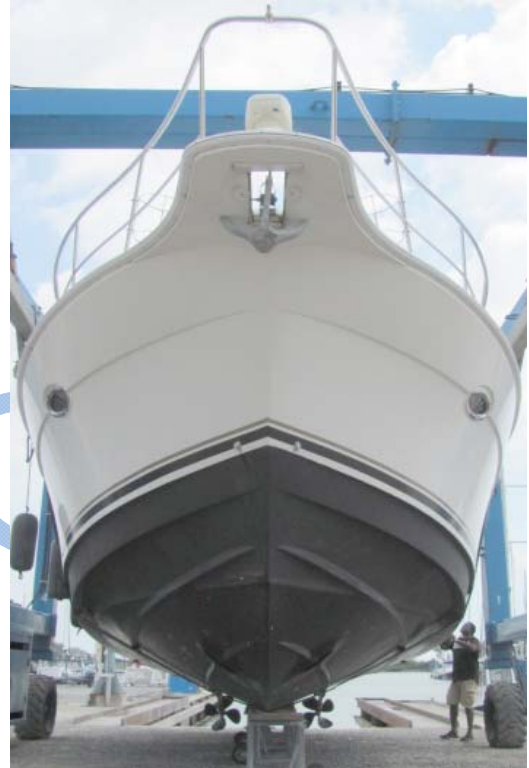
Bulkheads/frames : The hull skin shows arc shaped fractures and the tabbing of two transverse bulkheads has separated under the berth in the guest stateroom. There are matching fractures on the exterior surface and a small area of dull checking. **See comment (2).**

Interior - Fractures between separated bulkheads

2. Repair separated and fractured tabbing under guest berth and seal external gelcoat fractures.
3. Strip anti-fouling paint and re-coat.
4. Secure ballast.

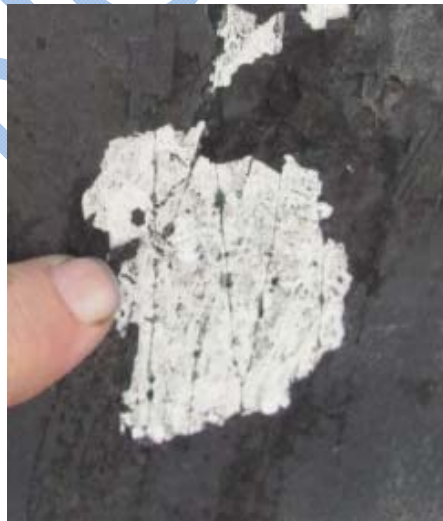
Exterior - fractures between separated bulkheads.

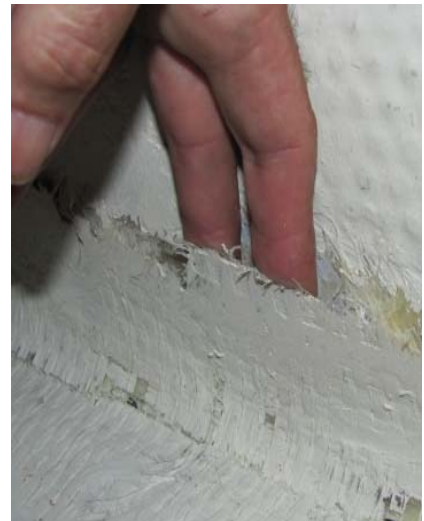
Interior separated bulkhead tabbing

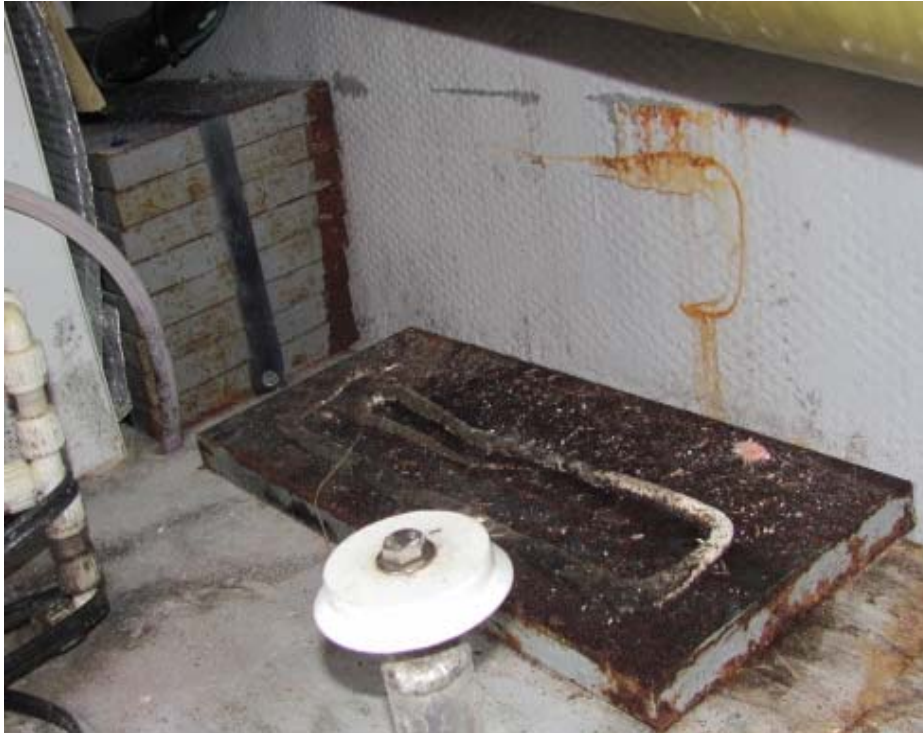
The cockpit deck and hatch check sound with moisture levels in the low range. In the lazarette under the cockpit there is a leak at the starboard transom corner and approximately 367lbs. of inadequately secured and one unsecured steel ballast plates. [See comment \(4\).](#)

*Approximately 367lbs. of unsecured and
Inadequately secured ballast*

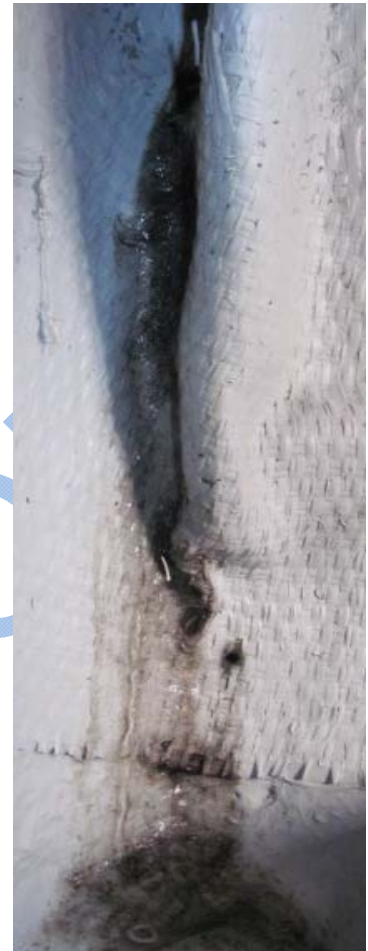
Stb. transom leak

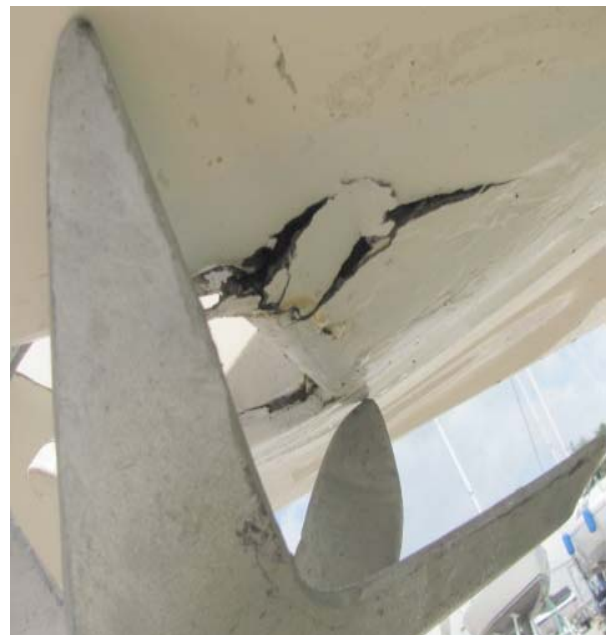
The rode locker hatch and area around the windlass foot switches check dull and show high moisture levels. The underside of the bow platform laminate is through fractured. [See comment \(5\).](#)

Underside bow platform fractured

5. Re-bed windlass foot switches and repair underside of bow platform.
7. Shaft mis-alignment may be due to position in slings and blocking. Port shaft should be closely monitored for vibration during sea trial. Loose retaining collar on port shaft to be secured. Missing retaining collar on starboard shaft. To be replaced. Both stuffing boxes to be closely monitored during sea trial and if there is movement, this becomes an "A" recommendation.

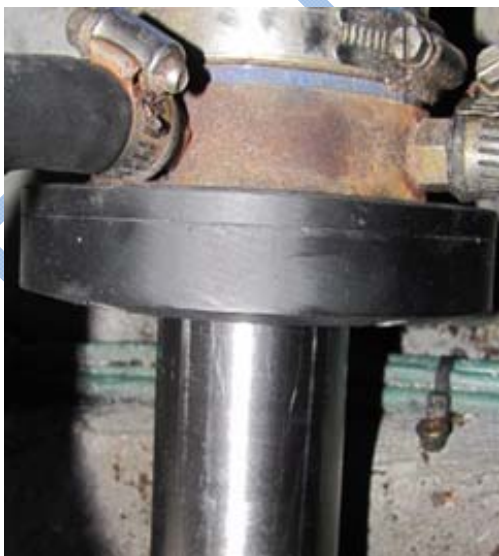
- Steering :** Hydraulic to single ram and tie rod to tiller arms are secure and responsive with no visible leakage.
- Rudders :** Semi-balanced bronze spades with bronze compression type stuffing boxes show surface corrosion indicative of salt water usage but are secure and sound.
- Propellers :** Two 4-blade bronze units are fair and secured with nuts, jam nuts and cotter pins, all in good order. Port - 25LH29, Starboard – 25RH29
- Shafting :** Stainless steel shafts supported through intermediary and main struts with cutless bearings to dripless seal type stuffing boxes. The port shaft is not centered in the bearings. The port stuffing box retaining collar is very loose and the starboard retaining collar is missing.
See comment (7).

Starboard shaft – stuffing retaining collar missing

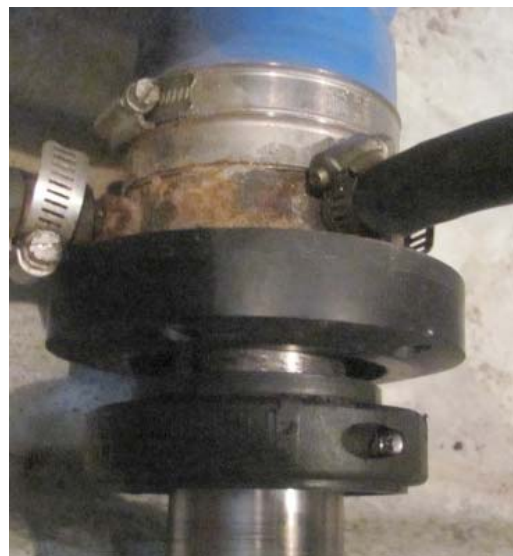
Port shaft - Stuffing retaining collar loose

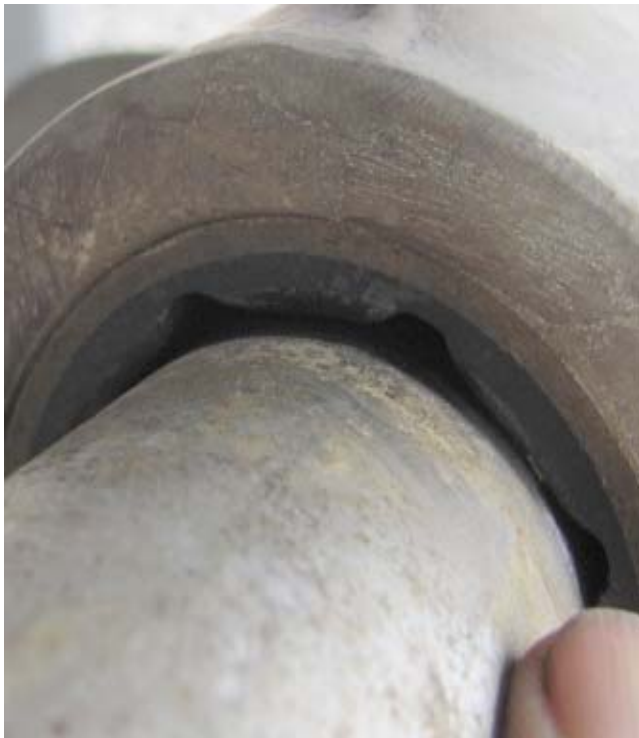
Port main- off center

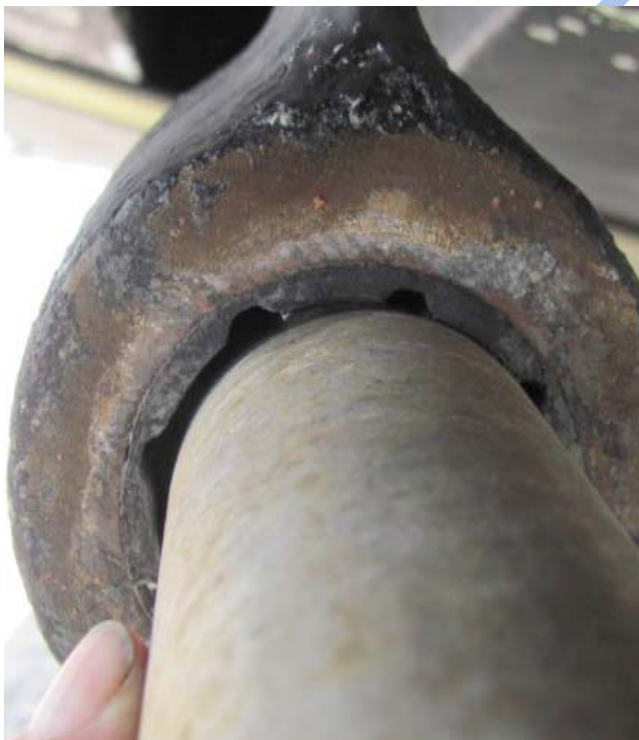
Port intermediary- off center

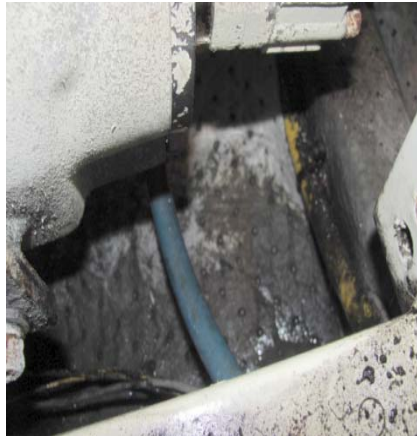
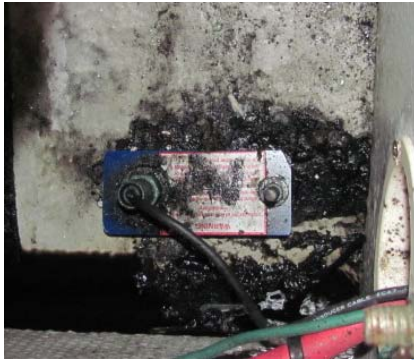
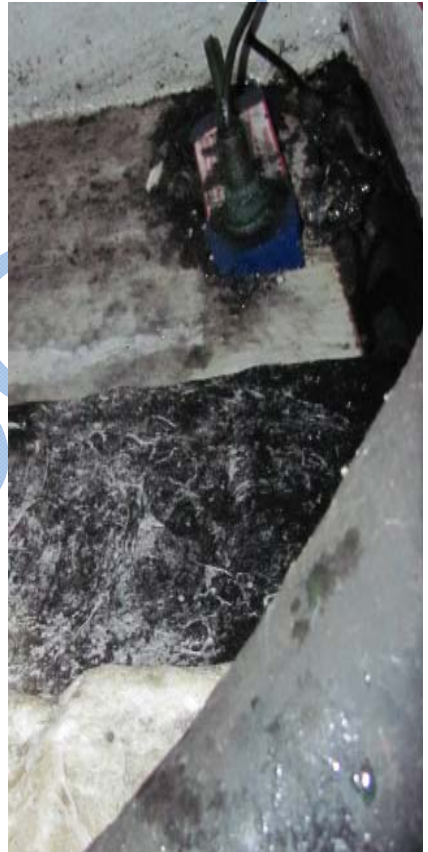
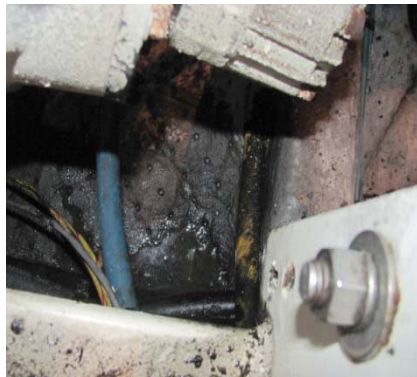
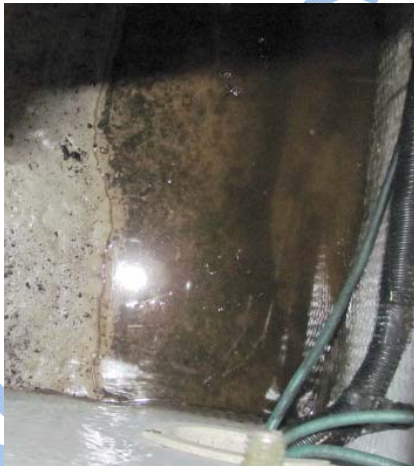
Engine oil is moderately clean in the port engine and slightly thicker and dirtier in the starboard engine. Gear reduction fluid is clean and at proper levels in both engines. Coolant scraped from the bottom of the heat exchangers is clean and at sufficient level in both engines. Gear reduction fluid is clean and at proper levels in both engines. Engine bilge compartments are heavily fouled with coolant, oily fluids and sitting water.

Various bilge compartments in engine room are heavily fouled

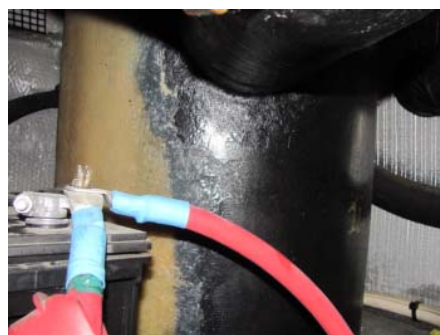
Exhaust system : Cast manifolds to FRP mufflers with type approved exhaust hose. All double clamped as required. A large area of the starboard muffler has been repaired with FRP as indicated by the un-gelcoated area. Muffler was originally gelcoated black. **See comment (11).**

Starboard muffler

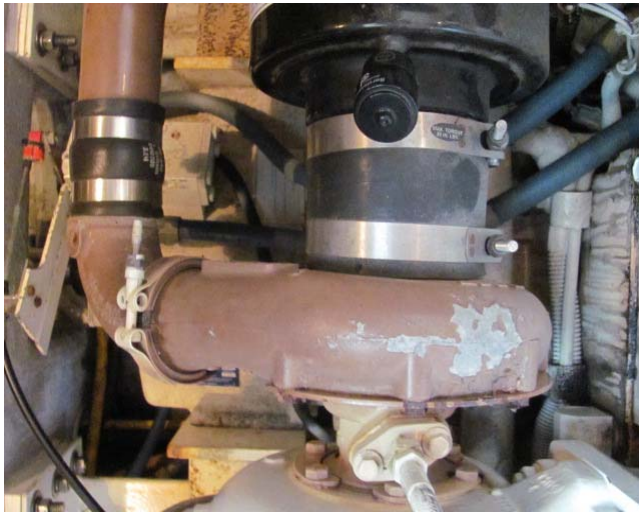
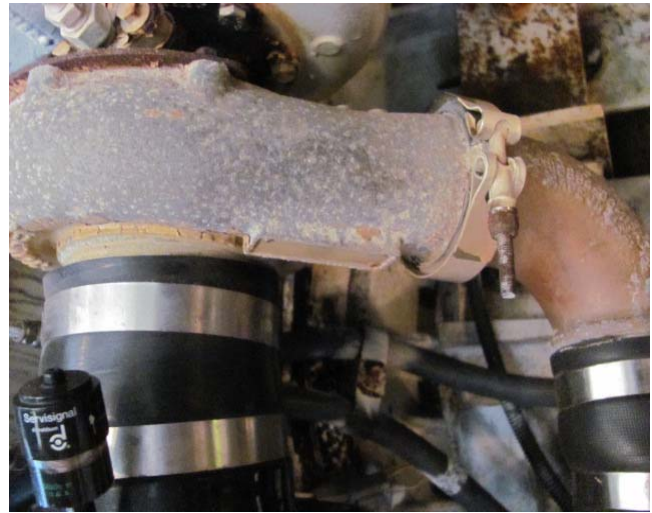
Turbo-chargers : While both turbos show signs of significant use and scorched paint, the starboard unit has lost virtually all of its paint and its mounting base shows much more corrosion than the port unit. **See comment (12).**

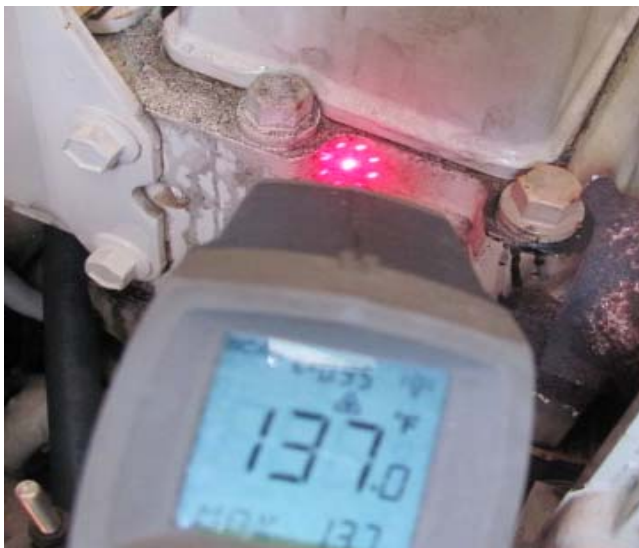
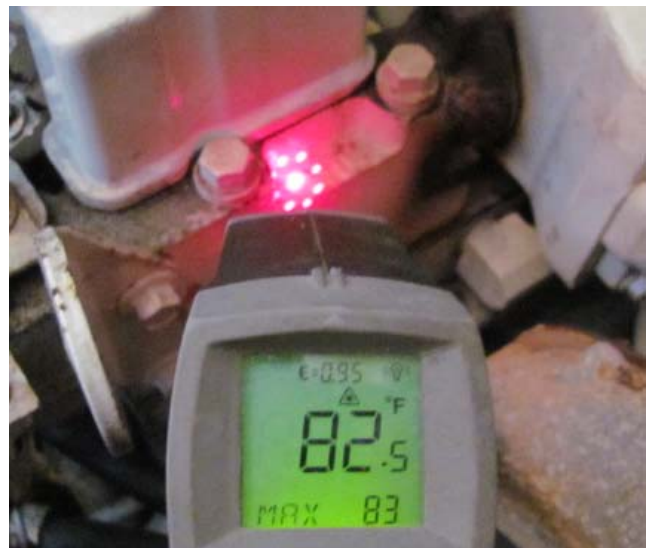
NOTE : The surveyor arrived at 0715hrs. At 0830 inspection of the engine compartment commenced to find the port engine near operating temperature (127°F) while the starboard engine was at 82°F, suggesting the engine had been run earlier that morning. At no time did the surveyor start the engines. **See comment (13).**

Port engine temp before startup 0830hrs

Starboard engine temperature before startup – 0830hrs

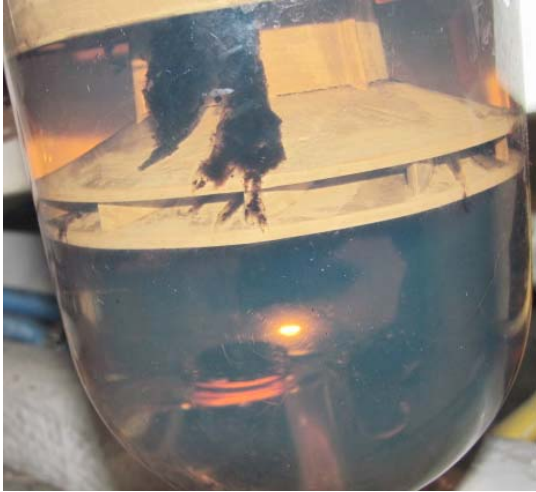
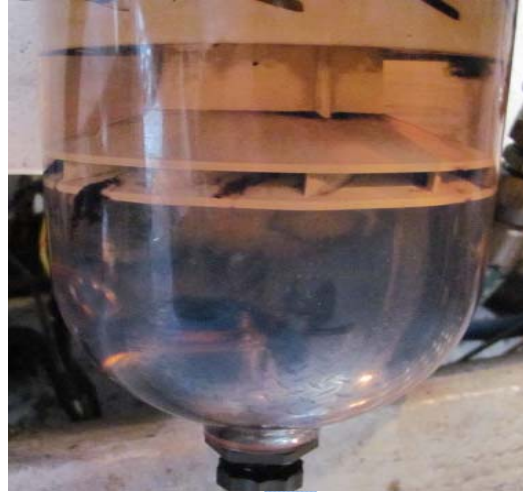
Fuel filters : Racor element type primaries with clear plastic bowls without heat shields are both mounted between the engines. Fuel in port filter is cloudy and both bowls contain some bacterial growth. **See comment (14).**

14. Clean engine and generator filter bowls of water and bacterial growth. Fuel analysis of remaining fuel in tank is advised.
15. Repair broken windlass casing, Repair broken windlass control at helm. Replace anchor chain with galvanized chain appropriate to the windlass gypsy. Replace bail on anchor roller with one that fits anchor.

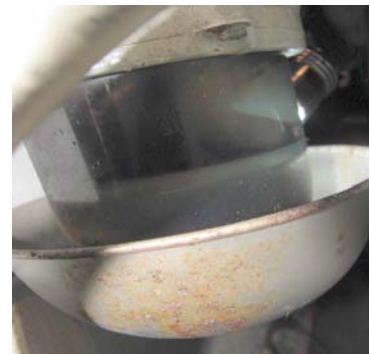
The generator is fitted within a sound box with integral drip pan. Exhaust is double clamped with type approved hose to and FRP muffler. Coolant is clean. Oil is thick and dirty. The fuel in the filter bowl is cloudy with a high water level.

Fuel filter

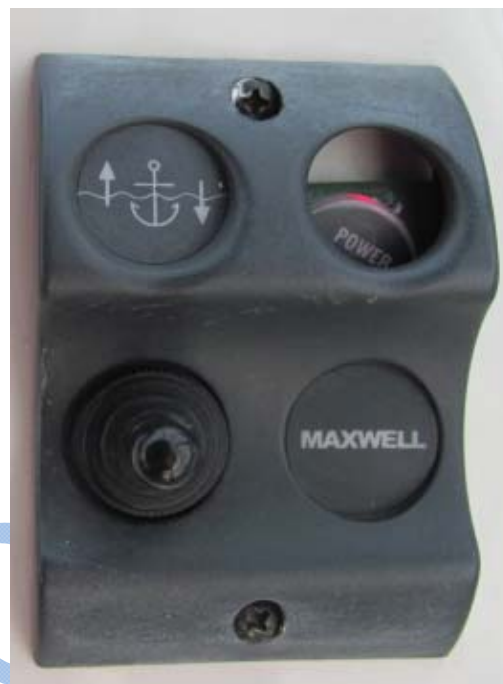
Windlass : Maxwell 12VDC vertical unit with chain gypsy. The unit did power up but jammed. The housing is broken and the chain does not appear to fit the gypsy or be of an appropriate grade metal. The "power" button at the control panel at is broken.
See comment (15).

Broken "power" button.

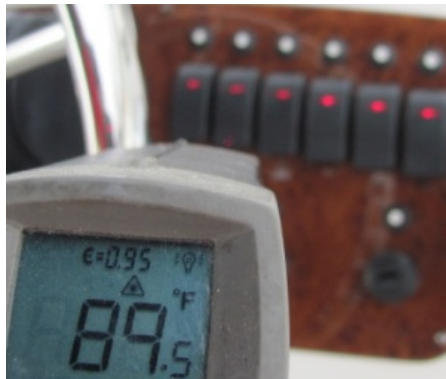
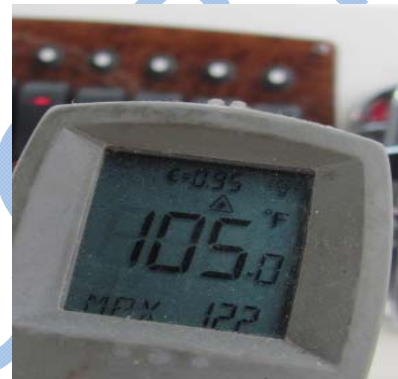
Conductors : Stranded copper where accessible and generally secure. The three accessory switches on the far starboard side of the helm are excessively hot at 105°F compared to the adjacent three which show only 89°F. **See comment (21).**

3 adjacent switches in same bank

3 starboard side. switches

10. Replace fractured hose.
21. Determine cause of excessively hot switches at helm and repair as required.
23. The client and the hired captain were advised that the one excessively hot battery is dangerous and should be disconnected. Given the fast rate of voltage drop, all batteries must be considered suspect. Replacement is advised however load testing by a qualified marine electrician may save one or more batteries.

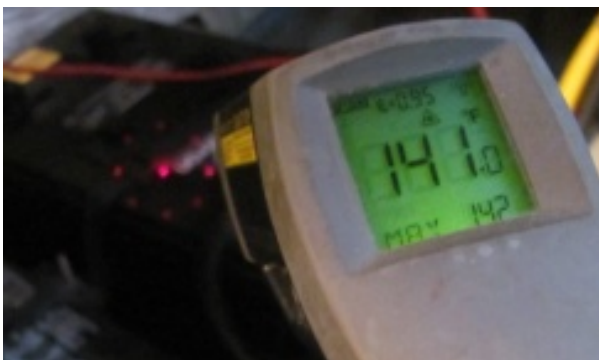
The number 4 wet cell battery is over gassing and excessively hot with an at rest temperature of 141°F and exposed plates.

No. 5 battery at rest 141°F

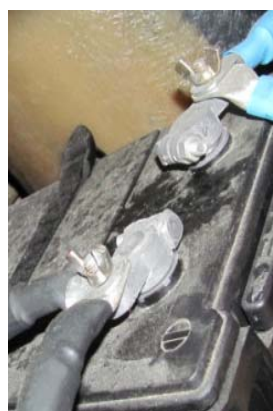
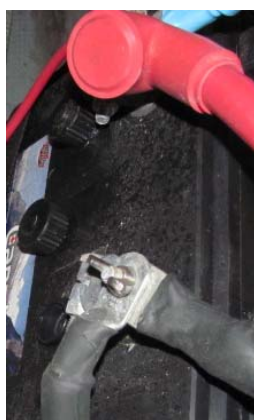
Batteries : There are eight 12VDC batteries with three being AGM and five being lead acid wet cells. Only four of the eight are in acid resistant trays, Only four are adequately secured. Almost all conductors are connected with wing nuts and almost all of those are extremely loose. Only one is fitted with secure positive terminal protection.

Loose wing nuts, unprotected positive terminals, unsecured batteries, low electrolyte

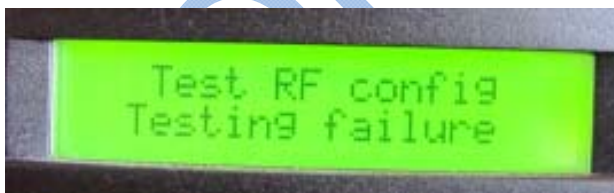
Entertainment : Four LCD TV's did power up but received no signal from the KVH antenna which showed an error message. A KVH satellite phone was not tested. **See comment (26).**

Satellite error message

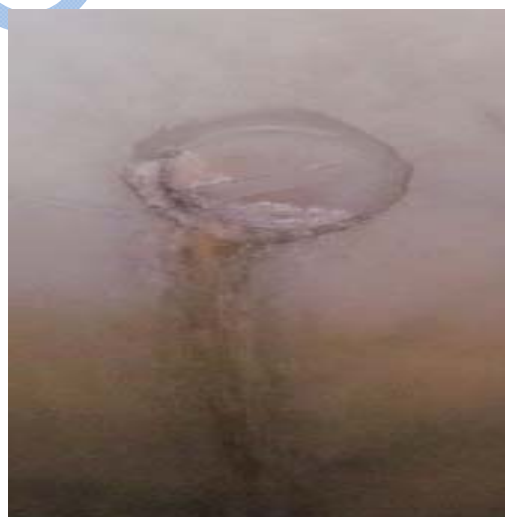
Potable water : 12VDC pressure system supplied from two polyethylene tanks in the engine compartment. The system did power up but the tanks were empty therefore it is not known if the system leaks or holds pressure. The starboard tank shows leak tracks around a molded "button" on the inboard side of the tank. **See comment (27).**

Leak stain on water tank

24. Ensure continuity of less than one ohm between any anode and the metal to which it is secured.
25. Repair galvanic isolator as required.
27. Fill water tanks and inspect the leak stain on the starboard tank. Test pump for ability to hold pressure.
