## Marine Survey Report

**Report Number :** 2010P/1844  
**Date of Inspection :** November 2, 2010  
**Commissioned by :** XXXXXXXXXXXX for pre-purchase purposes  
**Address :** XXXXXXXXXXXX  
XXXXXXXX  
XXXXXX  
**e-mail :** XXXXXXXXXXXXXXXX  
**Phone :** 647-XXX-XXXX

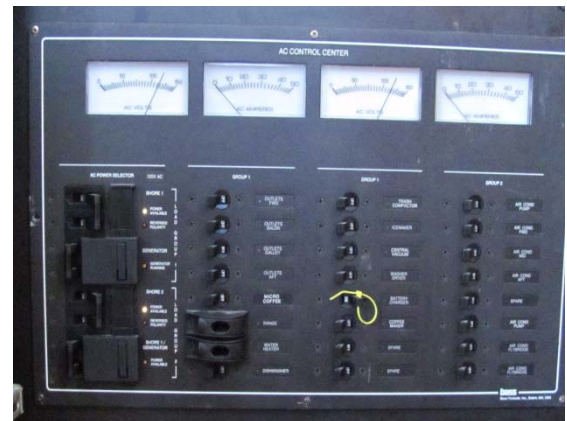
*AC panel*

**AC panel :** Double pole main breakers with polarity indicators in cockpit. Original equipment type panel with double pole main breakers, polarity indicators, volt meters, ammeters and accessory breakers in good in working order.
