MARINE SURVEY REPORT

Report Number : 2006P/1004
Date of Inspection : August 18, 2006
Commissioned by: [REDACTED] for condition and evaluation purposes
Address : [REDACTED] East
Stoney Creek, Ontario
L8E [REDACTED]
Phone : 905-[REDACTED]-[REDACTED]
e-mail: [REDACTED]

Make of Vessel -- Marine Trader built by Chien Wha Yard, Taiwan.
Name of Vessel -- [REDACTED]
Model year -- 1985
Date of mfg. -- February 1985
License Number -- 25E [REDACTED]
HIN/MIC -- ETY [REDACTED] B585

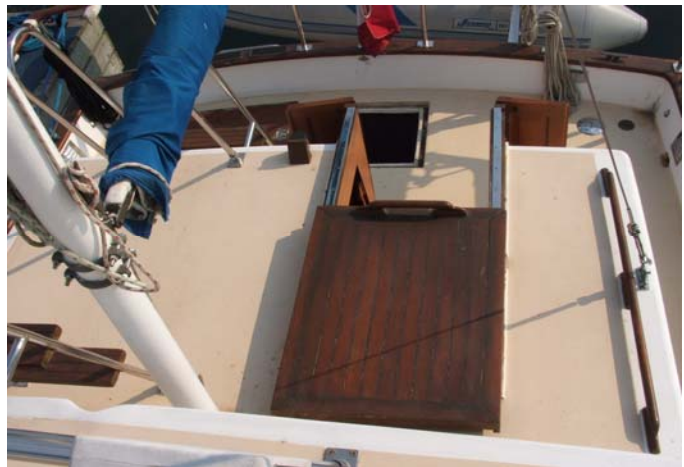
The aft deck is fitted with a plywood hatch cover which provides access to the steering gear and is warped but serviceably sound. A stainless steel ladder from the aft deck to the trunk top is secure. A sliding wooden companionway hatch and wooden doors to the aft cabin are secure and in good order.

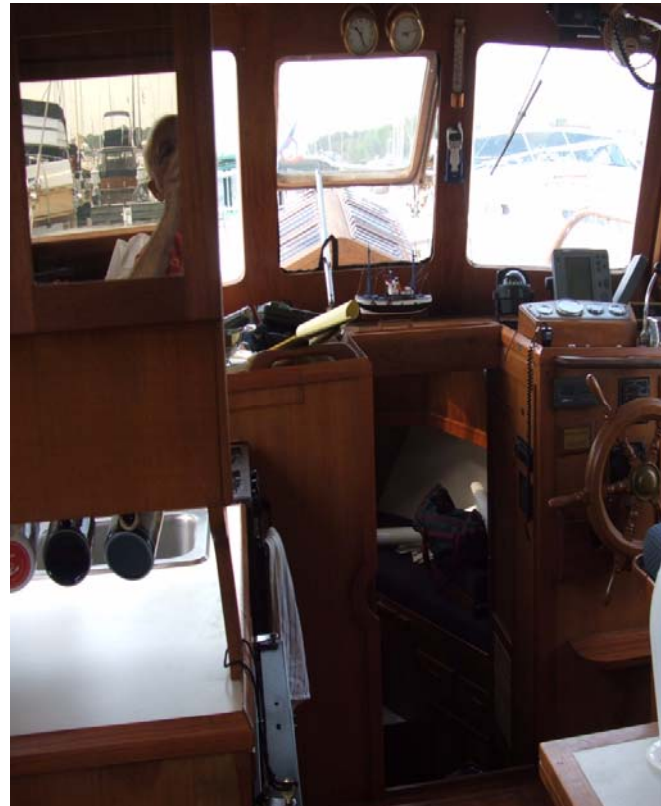
The interior teak soles, upholstery vinyl headliners and cabinetry are in clean, sound and secure condition. The lower edges of several Teak plywood panels are water stained with some non-structural delamination. [See comment \(4\).](#)

2. This "loose" repair on the starboard chine should be excavated and repaired as required.
3. Various high moisture and fractured areas pose no threat to the vessel but do have a negative effect on value.
4. Re-bedding all deadlights, ports and windows may help reduce leakage and further water staining.
7. Canada Shipping Act – TP1332E 7.7.1 requires every fuel filter or strainer shall meet the fire resistance requirements for fuel systems set forth in ABYC Standards for Small Craft H-24.5.7 unless the filter or strainer is inside the fuel tank. No plastic bowl filters without heat shields meet this standard.
