MARINE SURVEY REPORT

Report Number : 2009S/1582
Date of Inspection : October 30, 2009
Commissioned by : [REDACTED] for pre-purchase purposes
Address : [REDACTED]
Laval Québec
H7C XXX
e-mail : [REDACTED]@ [REDACTED].com
Phone : 514-771- [REDACTED]

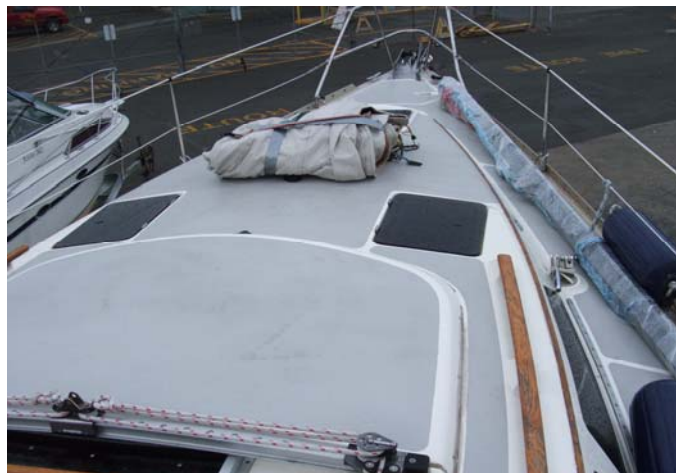
Stainless steel bow and stern rails are connected through stainless steel stanchions with double lifelines fitted with port/starboard and stern gates and all appear secure as do bow, midship and stern mooring cleats, Aluminum extruded toe rails are fair and secure. A crudely fashioned stainless steel stemhead plate with dual anchor rollers is secure. On the trunk four ports, four acrylic deadlights, one acrylic escape hatch with non-functional solar powered vent, four acrylic vent hatches, teak grab rails and an FRP spray shield all of which appear sound and secure. [See comment \(7\)](#).

4. Filler and corrosion to be removed from keel for further examination.
6. These deck / trunk flaws pose no threat to the vessel and may be repaired at the owner's discretion.
7. Repair solar vent as required.
8. Service #17 winch.
9. Transport Canada TP1331E "Construction Standards For Small Vessels" requires that each metal or metallic plated component of the fuel fill system, fuel tank and must be grounded so that its resistance is less than 1ohm.
12. Canadian Coast Guard "Collision Regulations" require a vessel of less than 20 meters or constructed of non-metallic materials to be equipped with a passive radar reflector if the vessel will operate in an area where radar navigation is in use, after sundown or in unfavourable environmental conditions.
16. Replace propeller shaft anode.
22. TP1332E requires that a *Safety Notice Compliance* label be fitted.

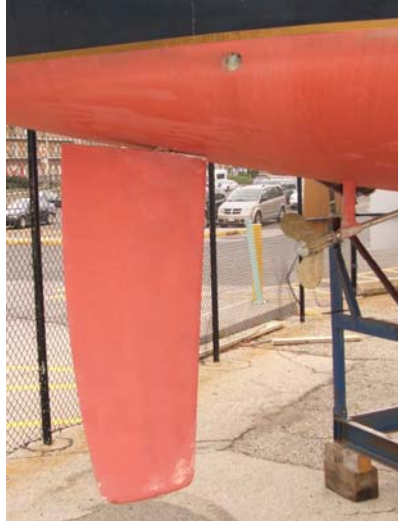
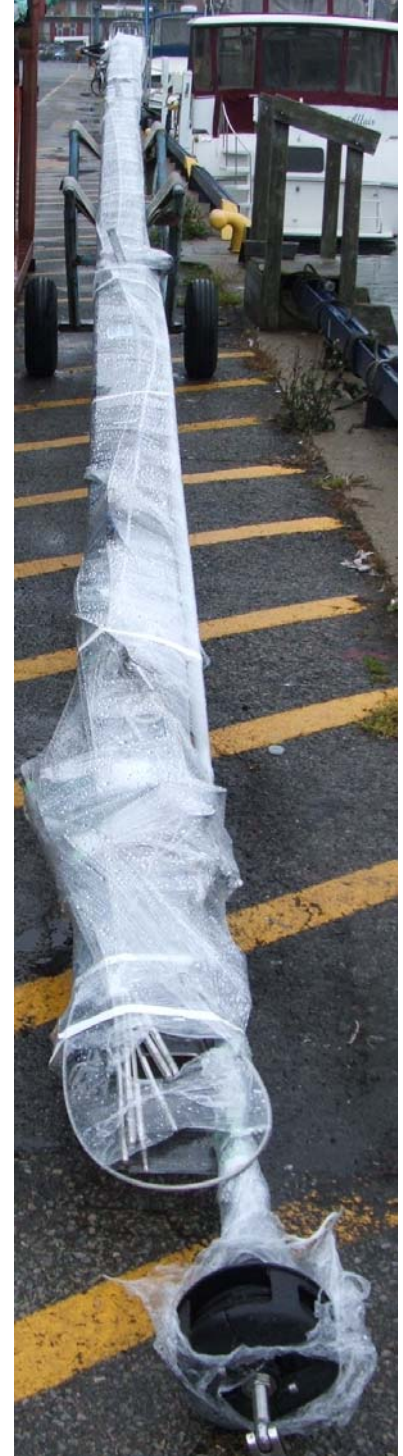
- Steering :** Wheel to cable and pullies are secure and free moving.
- Rudders :** An unbalanced hung spade shows evidence of repair and checks sound.
- Shafting :** A stainless steel shaft is supported through a bronze strut with cutless bearing to a dripless type stuffing box that appears near new.
- Propellers :** One three blade feathering bronze unit is secure and in good order.

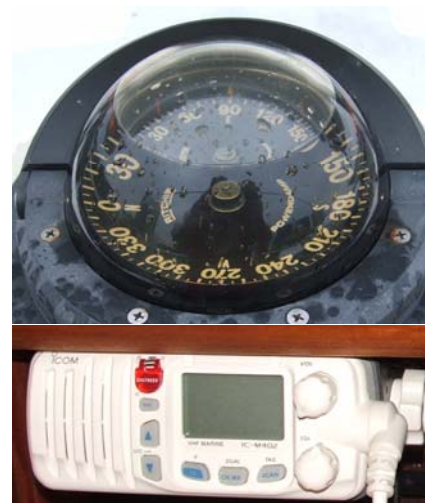
- Navigation lights:** All in place as required by Collision Regulations and powered up. The owner reported that the port running light was not working but it did power up.
See comment (11).
- Compass :** Ritchie 4" fluid damped type is clear and responsive to magnetic influence.
- Radar :** n/a
- Radar reflector :** None rigged. See comment (12).
- Chart plotter :** Raymarine C70 powered up.

11. Port running light conductor is corroded and not reliable.
13. Transport Canada "Constructions Standards For Small Vessels", TP1332E requires AC and DC distribution systems not share the same panel board and if both systems share a common enclosure must have a means of clearly separating the two systems with a dielectric barrier. ABYC "AC and DC Electrical Systems on Boats", Standard E-11 permits AC and DC to share the same panel but requires that access to energized parts of the AC side need further use of tools. A volt meter is required if a battery charger is connected.

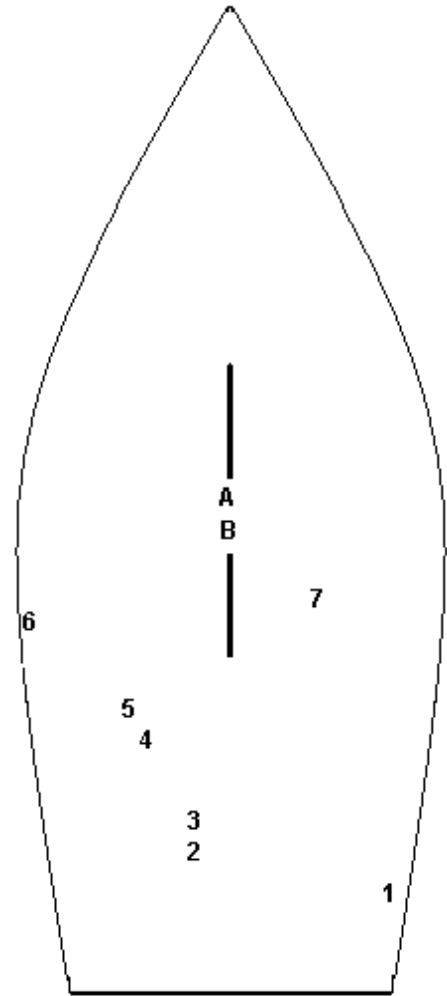
1. Exhaust outlet double clamped, no seacock required.
2. Head intake. Metal lever activated ball valve, double clamped.
3. Engine intake. Metal lever activated ball valve, double clamped.
4. Black water direct discharge. Metal lever activated ball valve, double clamped.
5. Y-valve to black water discharge. Metal lever activated ball valve, double clamped.
6. Vanity sink drain, No seacock.. Metal lever activated ball.
7. Galley sink drain. Metal lever activated ball valve, double clamped.

See comment (17).
