Marine Survey Report

Report Number : 2010S/1882
 Date of Inspection : January 01, 2011
 Commissioned by : XXXXXX XXXXXX
 Address : XXXXXXXXXXXXX
 XXXXXXXXXXXXX
 XXX XXX
 e-mail : XXXXXXXXXXXXX
 Phone : 416-XXX-XXXX

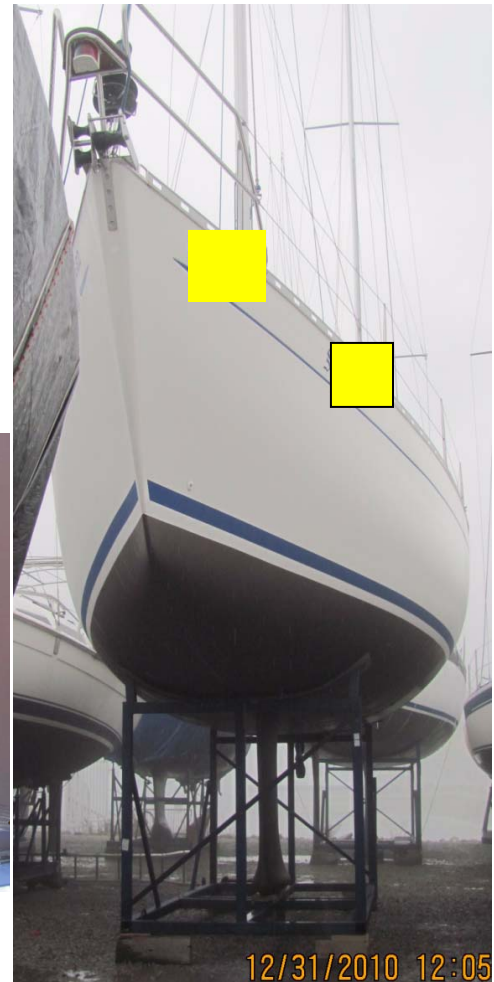
Decks / trunk : Moisture levels were not measured due to rain. All surfaces check sound but the decks outboard and aft of the lower forward shroud creak when walked upon. [See comment \(2\)](#).

2. The creaking deck and metallic popping sounds from the shroud rods appear to be at least partially caused by extremely tight rigging. Rigging should be loosened when the vessel must be stored in a cradle with the mast stepped.

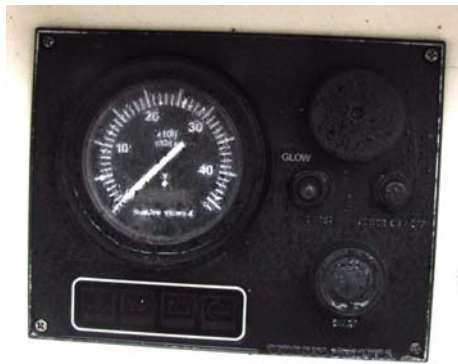
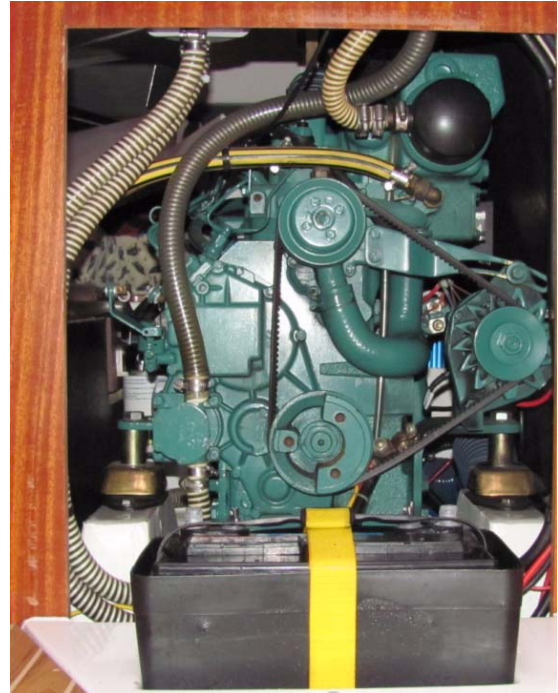
- Engine mounts :** Conventional steel mounts with flexible bushings forward, bolted to FRP beds. Saddle type mount with flexible bushing aft and all are in good order.
- Engine controls :** Dual function lever to cables is secure and free moving. Engine ignition panel includes a tachometer and warning lights only. No oil pressure or engine temperature gauges are fitted. See comment (3).

- Ventilation :** Satisfactory.
- Drip pans :** Integral to FRP Bed.
- Cooling system:** Heat exchanger with raw water exhaust cooling. No coolant visible in heat exchanger and no expansion reservoir fitted. See comment (4).
- Exhaust system :** Cast manifold to hose type muffler with stainless steel end caps. All double clamped as required and in good visual condition.

3. The addition of engine temperature and oil pressure gauges is advised.
6. Canadian Coast Guard "Collision Regulations" require a vessel of less than 20 meters or constructed of non-metallic materials to be equipped with a passive radar reflector if the vessel will operate in an area where radar navigation is in use, after sundown or in unfavourable environmental conditions.

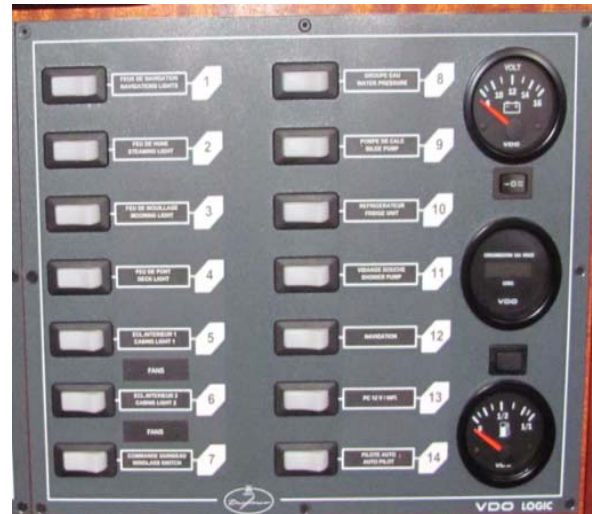
DC panel : Original equipment type circuit breaker panel with volt meter and accessory breakers in good visual order.
