Marine Survey Report

Report Number : 2013P/2885

Date of Inspection : July 10, 2013

Make of Vessel : Silverton 410 Sportbridge

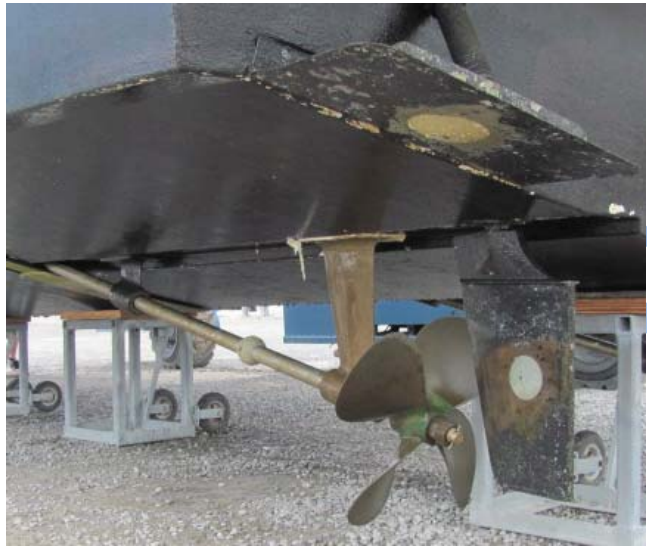
Port running gear

- Steering :** Hydraulic to single ram and tie rod to tiller arms are secure and responsive with no visible leakage.
- Rudders :** Semi-balanced bronze spades with bronze compression type stuffing boxes show surface corrosion indicative of salt water usage but are secure and sound.
- Propellers :** Two 4-blade bronze units are fair and secured with nuts, jam nuts and cotter pins, all in good order. Port - 25LH29, Starboard – 25RH29
- Shafting :** Stainless steel shafts supported through intermediary and main struts with cutless bearings to dripless seal type stuffing boxes. The port shaft is not centered in the bearings. The port stuffing box retaining collar is very loose and the starboard retaining collar is missing.
See comment (7).

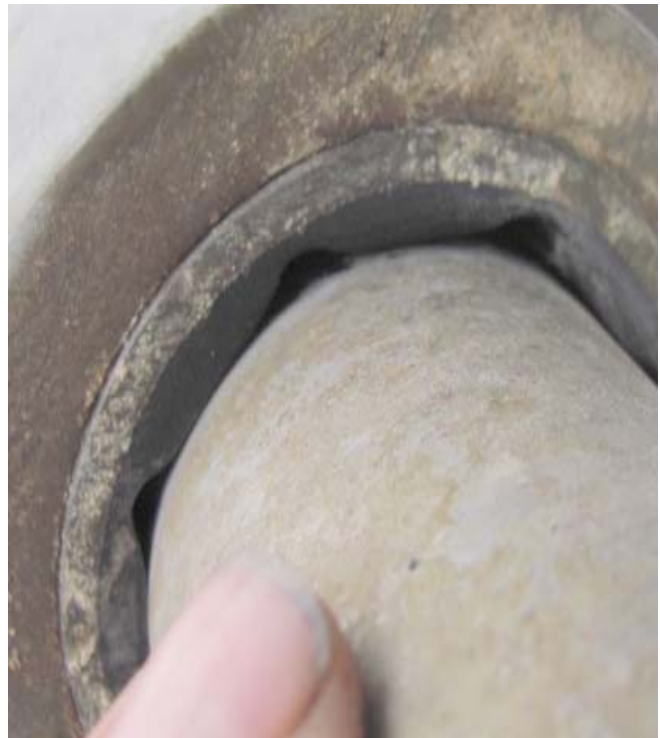
Starboard main strut - centered

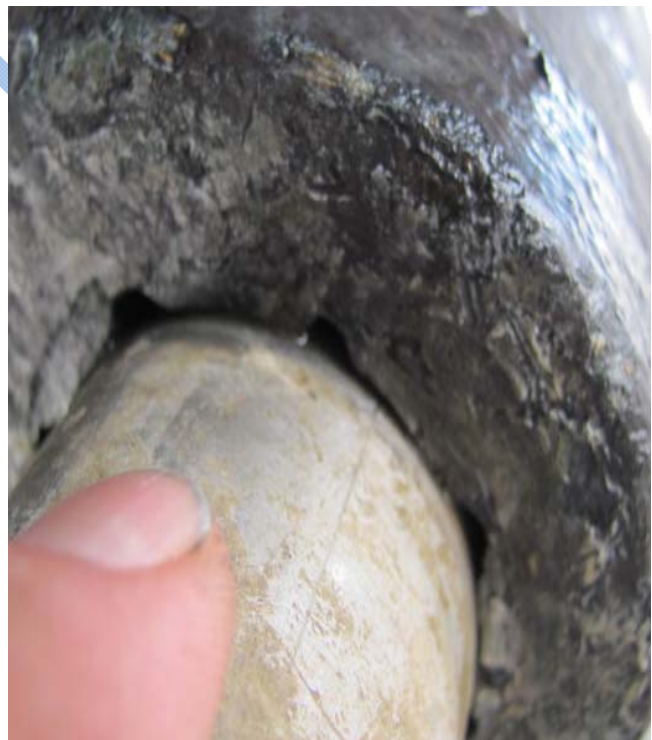
Starboard intermediary strut- centered

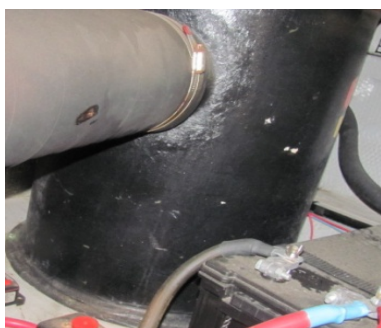
Port muffler

Exhaust system : Cast manifolds to FRP mufflers with type approved exhaust hose. All double clamped as required. A large area of the starboard muffler has been repaired with FRP as indicated by the un-gelcoated area. Muffler was originally gelcoated black. **See comment (11).**

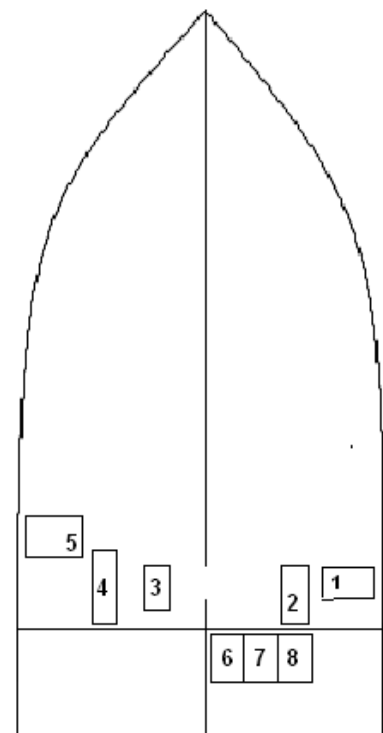
Battery map

Batteries : There are eight 12VDC batteries with three being AGM and five being lead acid wet cells. Only four of the eight are in acid resistant trays, Only four are adequately secured. Almost all conductors are connected with wing nuts and almost all of those are extremely loose. Only one is fitted with secure positive terminal protection.

The number 4 wet cell battery is over gassing and excessively hot with an at rest temperature of 141°F and exposed plates.

All batteries voltage dropped too fast with chargers turned off. **See comment (23).**

10. Replace fractured hose.
21. Determine cause of excessively hot switches at helm and repair as required.
23. The client and the hired captain were advised that the one excessively hot battery is dangerous and should be disconnected. Given the fast rate of voltage drop, all batteries must be considered suspect. Replacement is advised however load testing by a qualified marine electrician may save one or more batteries.

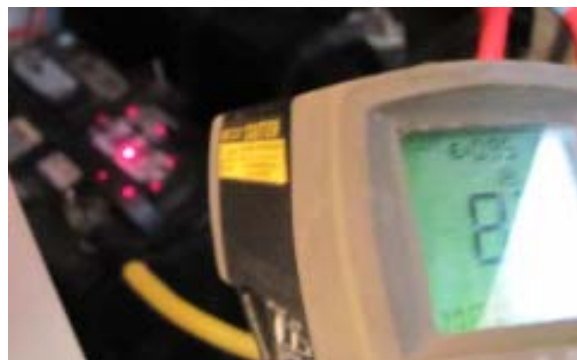
Others at rest 82°F
